Project Specific Asbestos, Lead Paint, and Arsenic Survey Report

**4474 Kukuihale Road
Anahola, Hawaii 96703**

4474 Kukuihale Road, Anahola (Lot 57)

Date of Report: February 22, 2022

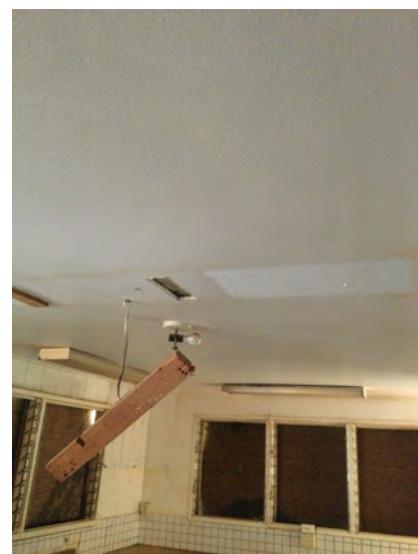
EMET ID	Building Number and Name		Inspection Date
2112615	4474	4474 KUKUIHALE ROAD	2/2/2022
Material ID and Description			
Document Number	615-4474-1B		WHITE GYPSUM WALLBOARD/MUDJOINT WALL AND CEILING SYSTEM
Unified Sample Area Number			
Drawing/Sketch Number		615-4474-1B

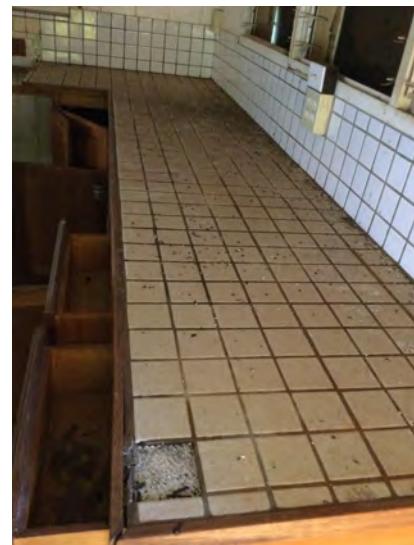
EMET ID	Building Number and Name		Inspection Date
2112615	4474	4474 KUKUIHALE ROAD	2/2/2022
Material ID and Description			
Document Number	615-4474-1C		2" X 2" WHITE CERAMIC TILE/GROUT/MORTAR
Unified Sample Area Number			
Drawing/Sketch Number		615-4474-1C

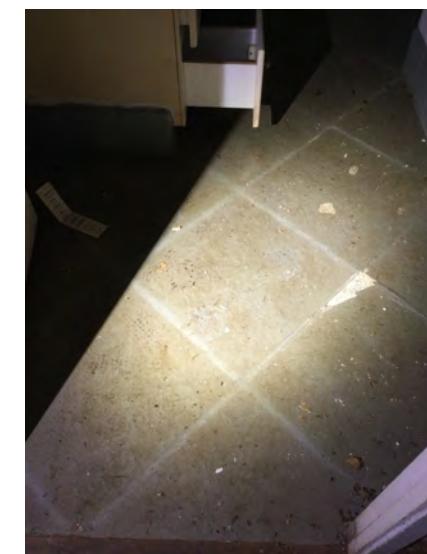
EMET ID	Building Number and Name		Inspection Date
2112615	4474	4474 KUKUIHALE ROAD	2/2/2022
Material ID and Description			
Document Number	615-4474-1D		14"X14" GRAY CERAMIC TILE/GROUT
Unified Sample Area Number			
Drawing/Sketch Number		615-4474-1D

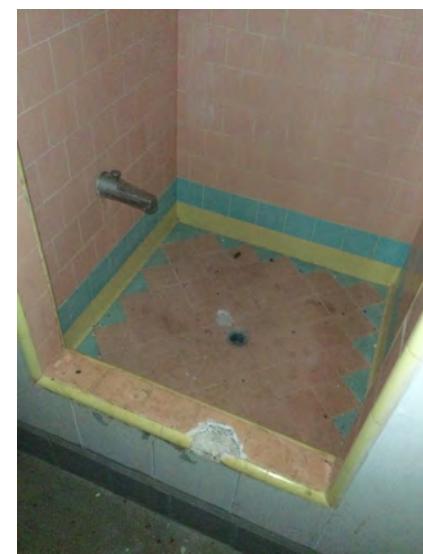
EMET ID	Building Number and Name		Inspection Date
2112615	4474	4474 KUKUIHALE ROAD	2/2/2022
Material ID and Description			
Document Number	615-4474-1E		4"X4" PINK CERAMIC TILE/GROUT/MORTAR
Drawing/Sketch Number			
			615-4474-1E

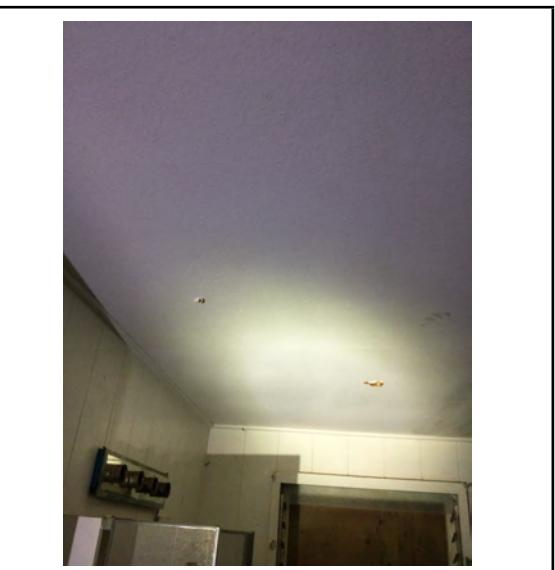
EMET ID	Building Number and Name		Inspection Date
2112615	4474	4474 KUKUIHALE ROAD	2/2/2022
Material ID and Description			
Document Number	615-4474-1F	WHITE W/BROWN CANEC BOARD	
Unified Sample Area Number			
Drawing/Sketch Number		615-4474-1F

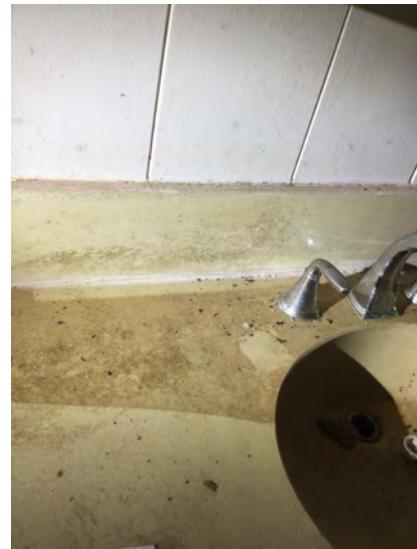
EMET ID	Building Number and Name		Inspection Date
2112615	4474	4474 KUKUIHALE ROAD	2/2/2022
Material ID and Description			
Document Number	615-4474-1G	WHITE CAULKING AT PLUMBING FIXTURE	Unified Sample Area Number
Drawing/Sketch Number			
			615-4474-1G

Total Number of Samples Collected	3
Samples Collected by	EMET
Sample Numbers	615-4474-1G1, 615-4474-1G2, 615-4474-1G3
Total Number of Samples Analyzed	3
Samples Analyzed by	EMET
ASBESTOS-CONTAINING MATERIAL ?	
Number of Salient Designations:

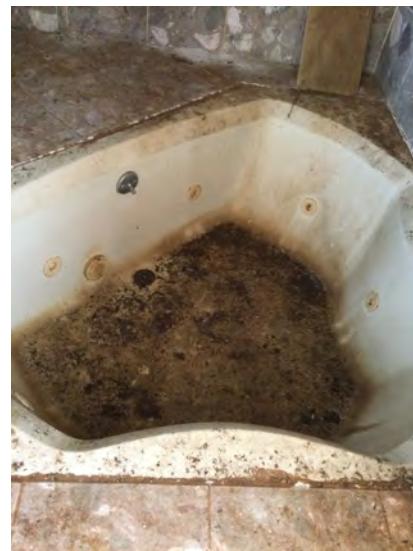
EMET ID	Building Number and Name		Inspection Date
2112615	4474	4474 KUKUIHALE ROAD	2/2/2022
Material ID and Description			
Document Number	615-4474-2C	WHITE CAULKING AT SHOWER BATHTUB	Unified Sample Area Number
Drawing/Sketch Number			
			615-4474-2C

Total Number of Samples Collected	3
Samples Collected by	EMET
Sample Numbers	615-4474-2C1, 615-4474-2C2, 615-4474-2C3
Total Number of Samples Analyzed	3
Samples Analyzed by	EMET
ASBESTOS-CONTAINING MATERIAL ?	
Number of Salient Designations:

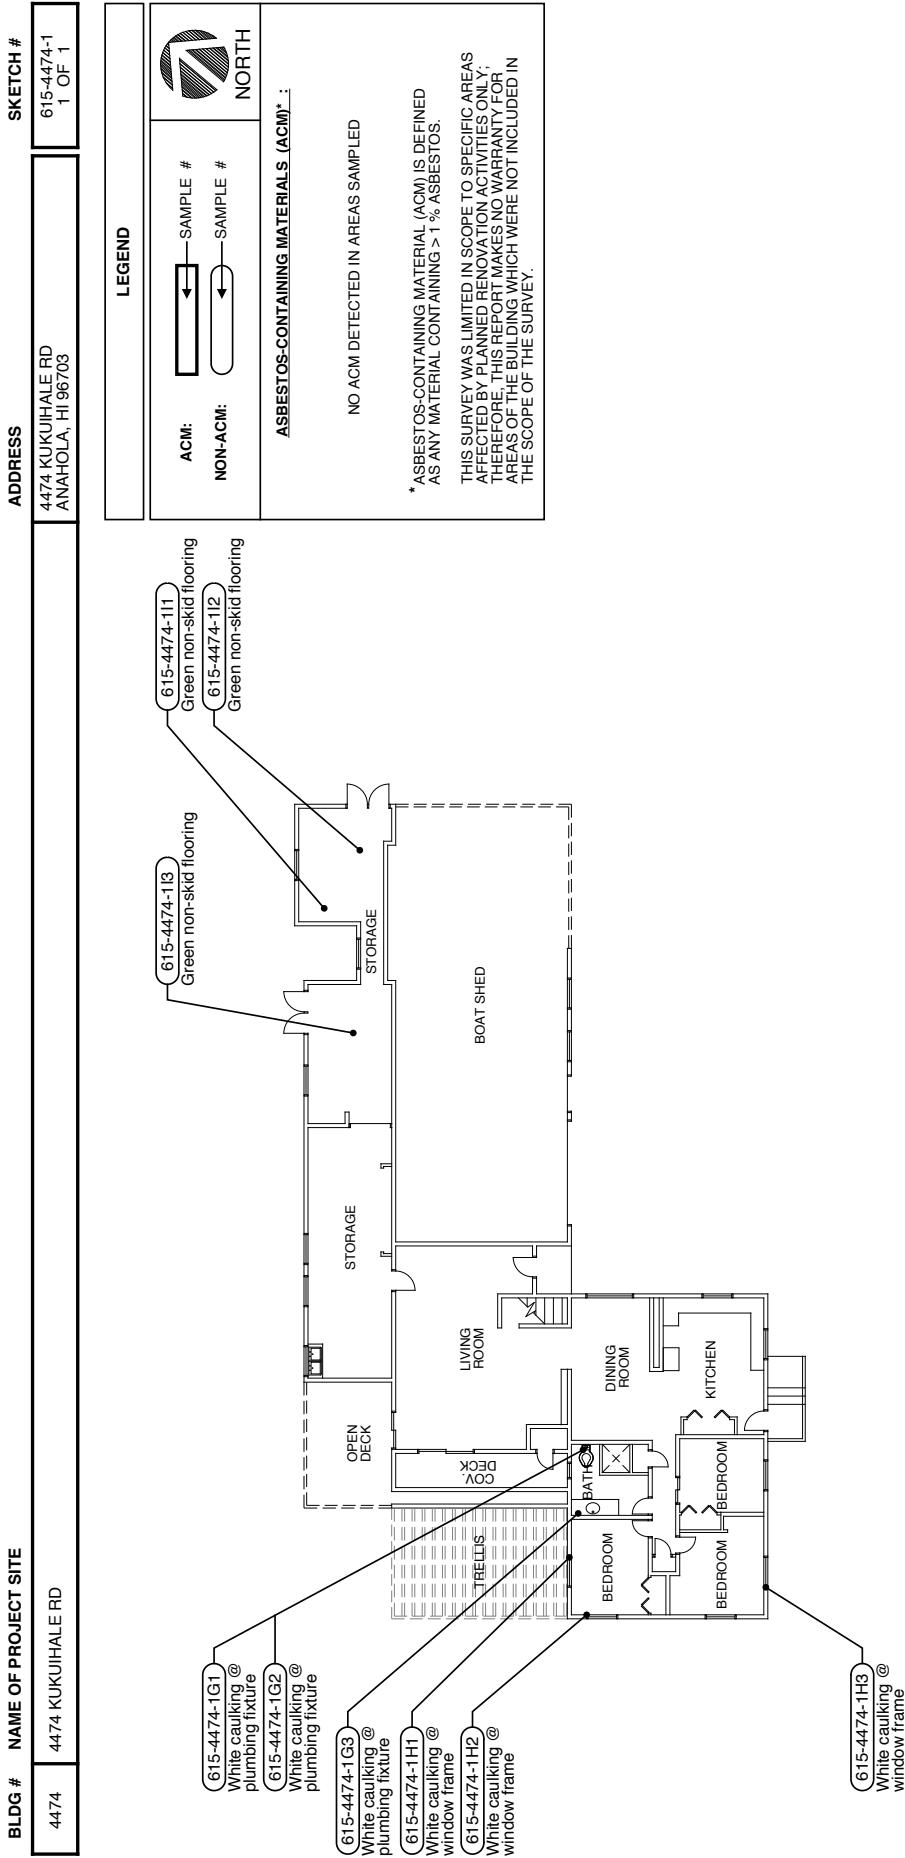
4474 KUKUIHALE RD - FIRST FLOOR PLAN
NOT TO SCALE

BLDG #	NAME OF PROJECT SITE	ADDRESS	SKETCH #								
4474	4474 KUKUIHALE RD	4474 KUKUIHALE RD ANAHOLA, HI 96703	615-4474-2 1 OF 1								
LEGEND											
<table border="1" style="width: 100%; text-align: center;"> <tr> <td>ACM:</td> <td></td> <td>SAMPLE #</td> <td></td> </tr> <tr> <td>NON-ACM:</td> <td></td> <td>SAMPLE #</td> <td></td> </tr> </table>				ACM:		SAMPLE #		NON-ACM:		SAMPLE #	
ACM:		SAMPLE #									
NON-ACM:		SAMPLE #									
ASBESTOS-CONTAINING MATERIALS (ACM)*:											
NO ACM DETECTED IN AREAS SAMPLED

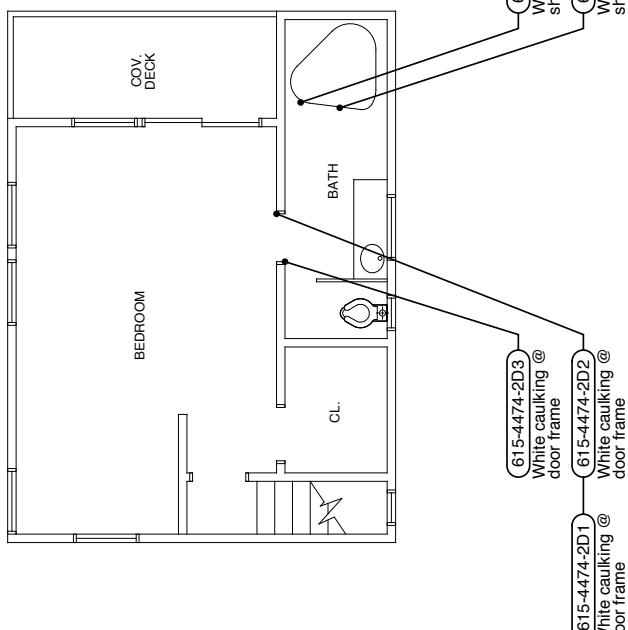
4474 KUKUIHALE RD - SECOND FLOOR PLAN
NOT TO SCALE

NORTH	ASBESTOS-CONTAINING MATERIALS (ACM)*: NO ACM DETECTED IN AREAS SAMPLED		
<p>* ASBESTOS-CONTAINING MATERIAL (ACM) IS DEFINED AS ANY MATERIAL CONTAINING > 1% ASBESTOS.</p> <p>THIS SURVEY WAS LIMITED IN SCOPE TO SPECIFIC AREAS AFFECTED BY PLANNED RENOVATION ACTIVITIES ONLY; THEREFORE, THIS REPORT MAKES NO WARRANTY FOR AREAS OF THE BUILDING WHICH WERE NOT INCLUDED IN THE SCOPE OF THE SURVEY.</p>
