HAWAII ISLAND STRUCTURE DEMOLITION & CLEARING

IFB-22-HHL-020

HAZARDOUS MATERIALS SURVEY REPORT
82 Andrews Avenue Lot No. 58-B-1, TMK (3) 2-1-021:072
Hilo, Hawaii

Photo Log
Seven homes on the Big Island of Hawai'i
82 Andrews Avenue Lot No. 58-B-1, TMK (3) 2-1-021:072
MEC Project No.: 2022-0034

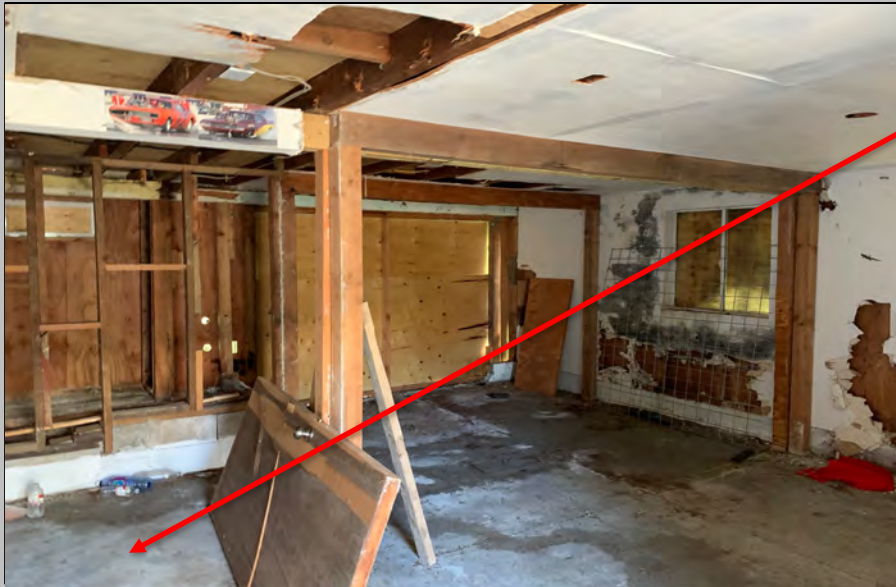
Photo No. 3: Downstairs

Lead-Containing Paint	Location	Condition	Estimated Quantity (Affected Area)
Gray paint on concrete floor (Photo 2)	Downstairs floor	Damaged	212.48 ft ²
White paint on concrete floor (Photo 3)	Downstairs floor	Damaged	148.15 ft ²
Green paint on concrete wall (Photo 4)	Outside the House	Damaged	5 ft ²

Lead-containing white paint on concrete floor.

No asbestos was found.

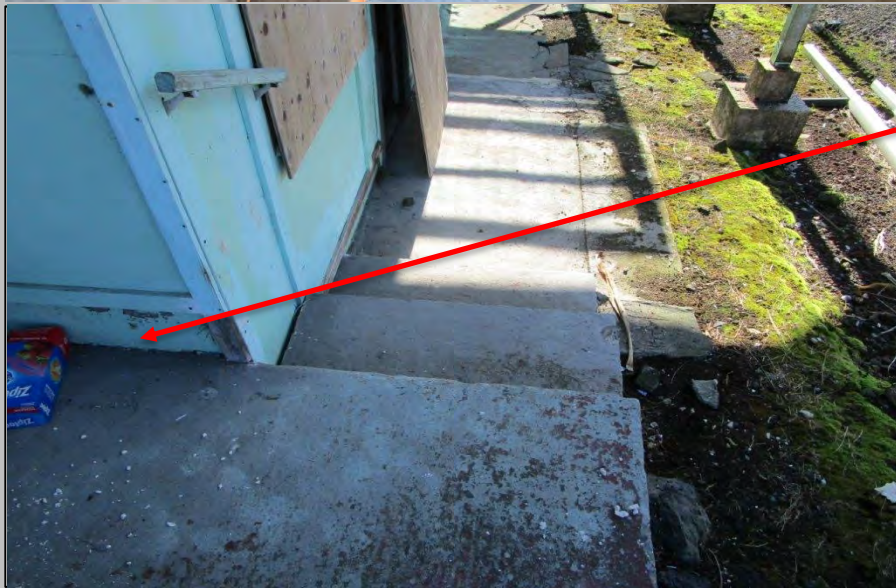
Photo No. 4: Outside

Lead-containing green paint on concrete wall.

No asbestos was found.

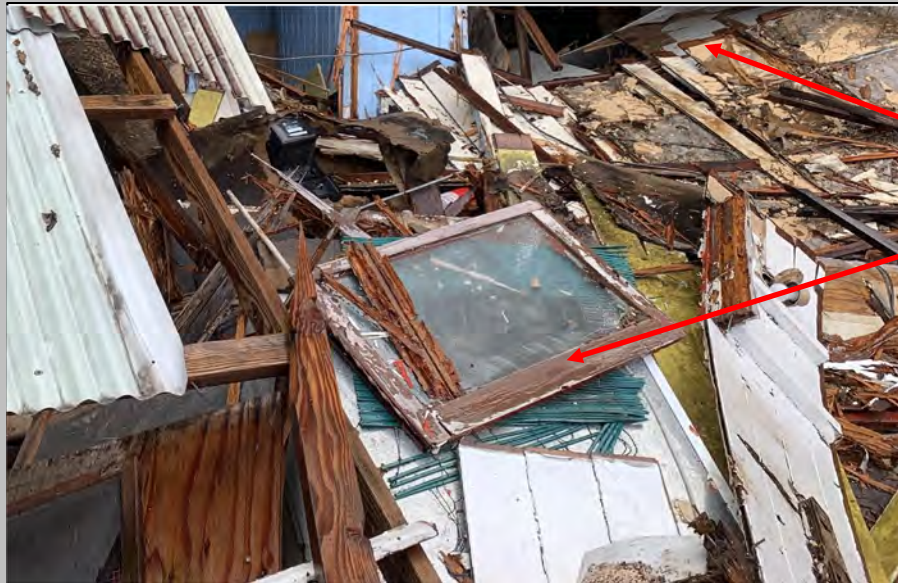
Photo No. 3:

Lead-containing, lead-based and arsenic tan paint on fiber board.
