DRAFT Site Preliminary Engineering Report Stadium Bowl-O-Drome Redevelopment May 2017

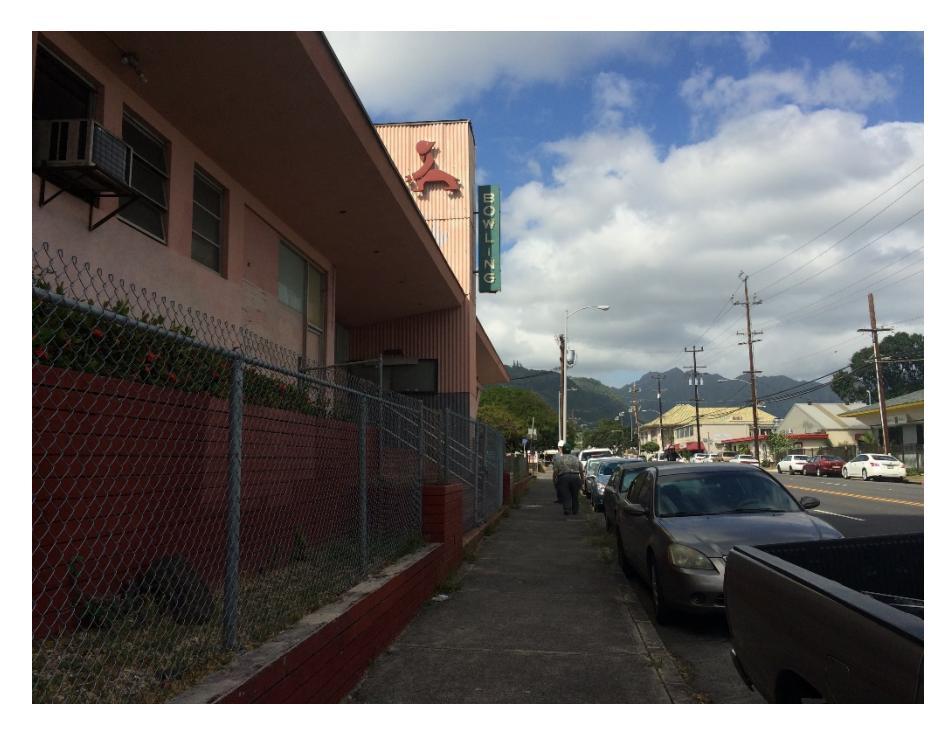
The property frontage is a 206.42 feet section along Isenberg Street, midblock between King Street and Citron Street. The existing entrance to the site is through a 24.0 wide driveway on the northern side of the property frontage from Isenberg Street.

Isenberg Street block, between King Street and Citron Street, is a 4-lane roadway with on-street parking. Fronting the site are 8 public parking stalls. The 8.0 foot sidewalk area is totally paved in concrete.

Figure 1: 820 Isenberg Street Frontage

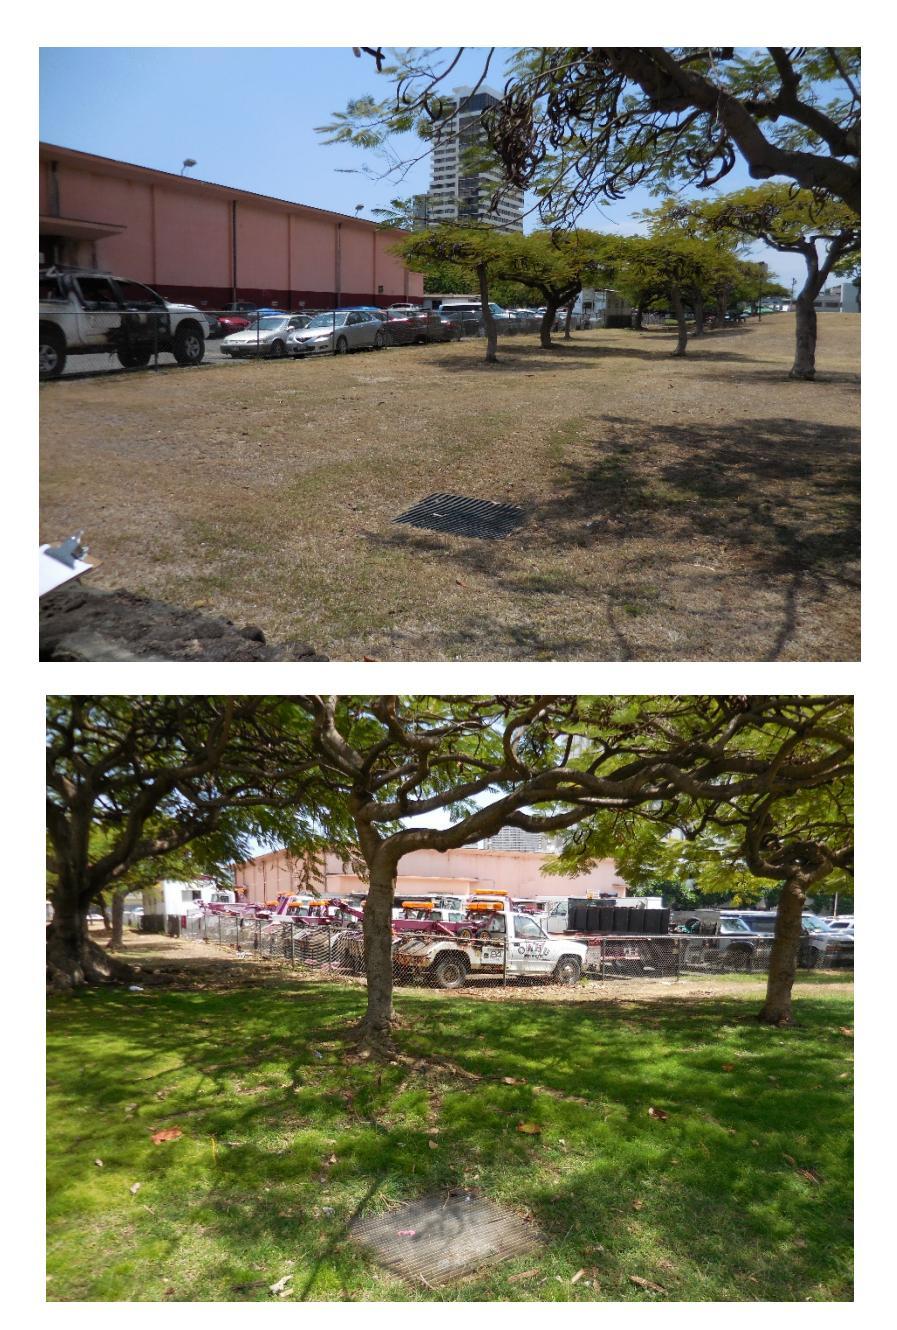
In addition, the Stadium Park directly mauka of the Bowl-O-Drome site has it own underground drainage system along the common property line of the 2 properties. See Figures 2 and 3 showing the drain inlets that collects the runoff from the Stadium Park before entering the Bowl-O-Drome site.

Figures 2 & 3: Existing Drain Inlets and Drainage System along northern property line in Stadium Park

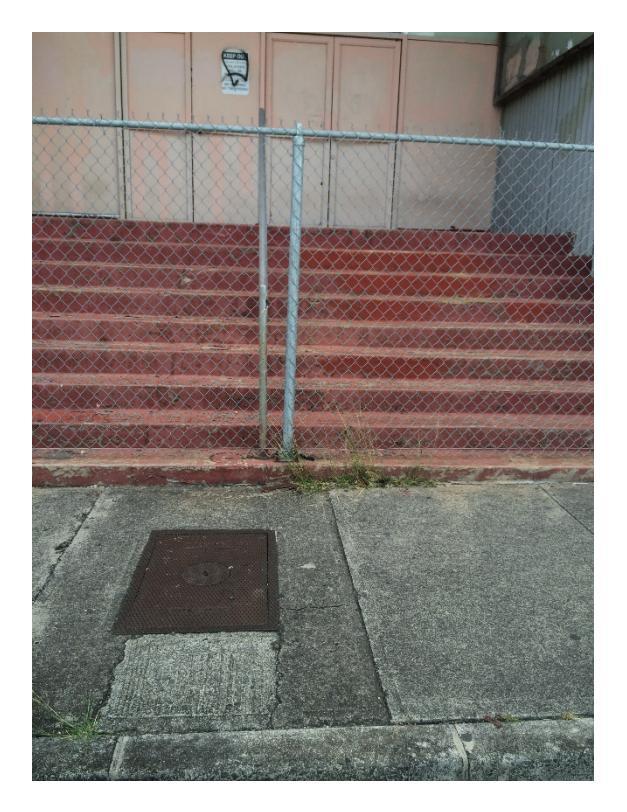
Within the Stadium Bowl-O-Drome site, beyond the water meter is an existing shutoff valve in the front steps. Beyond this there does not seem to be any exterior backflow preventers assemblies for the existing building and/or irrigations system.

The existing building does not seem to have any existing on-site fire protection or building sprinkler system. No separate FM meter was found.

Figure 4: Existing Water Meter and Shutoff Valve at Front Steps

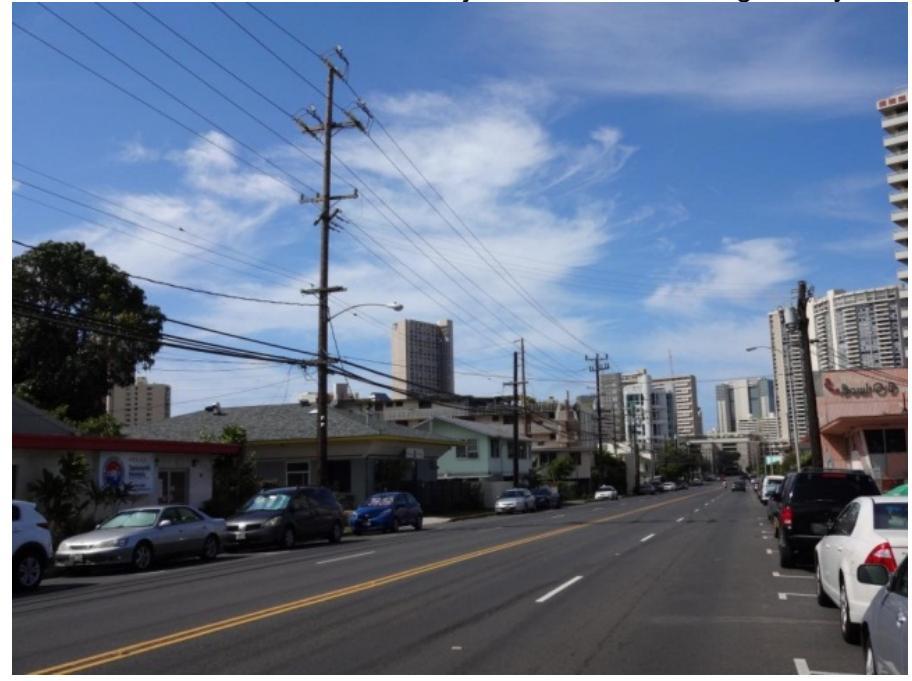
The electrical utility system in the area consists of overhead electrical distribution lines run on joint use wood poles. The pole line is located in the sidewalk area and runs along the east side of Isenberg Street across the street from the Bowl-O-Drome site.

## Figure 5: Existing Overhead Electrical Lines Along Isenberg Street

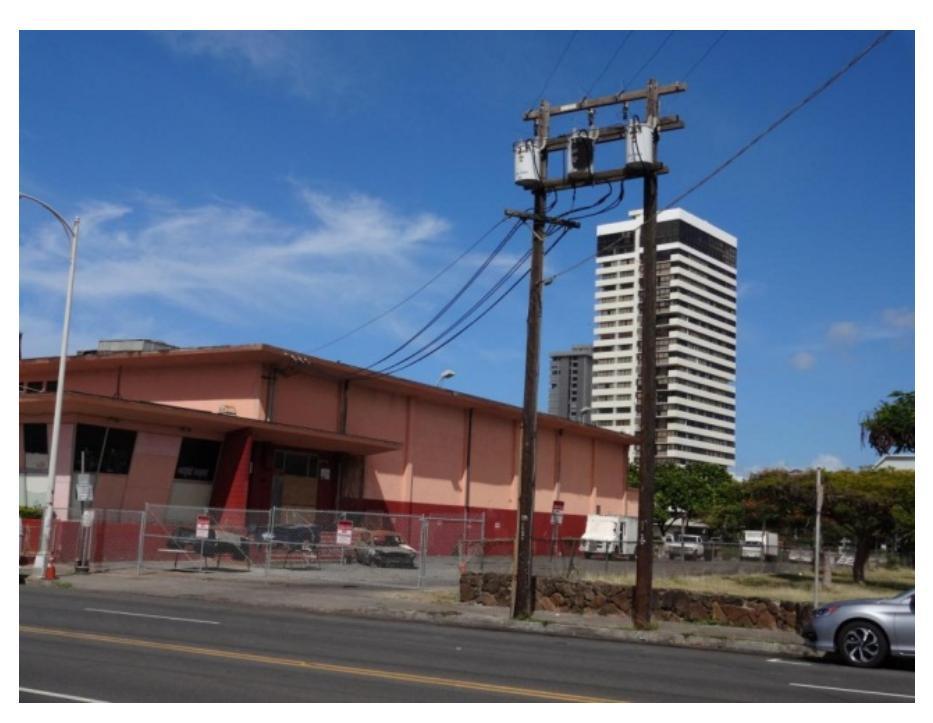
The Hawaiian Electric Company's (HECO) 12 kV circuit is "tapped" on pole #24 which is located across Isenberg Street from the site. The 12 kV circuit is then extended overhead across Isenberg Street to H-frame poles #24X and #24XX located at the sidewalk area near the northeast corner of the site. The H-frame poles support three single phase 50 kVA pole mounted transformers. This 150 kVA, 3 phase transformer bank appears to only provide electricity for the Bowl-O-Drome. There is an overhead service cable connection from the transformer bank to the northeast corner of the Bowl-O-Drome building. The overhead service drop terminates at two weatherheads mounted at the exterior of the building. There are two weatherheads because the service feeder consists of two parallel sets of 4 cables each. From the weatherheads the service feeder cables are run in conduit down the exterior of the building to a large wall mounted junction box. It appears that the service cables then enter the building to connect to the electrical service disconnect and HECO meter located just inside the building's entry.

### Figure 6: Existing Transformer Bank and Overhead Electrical Service to Property

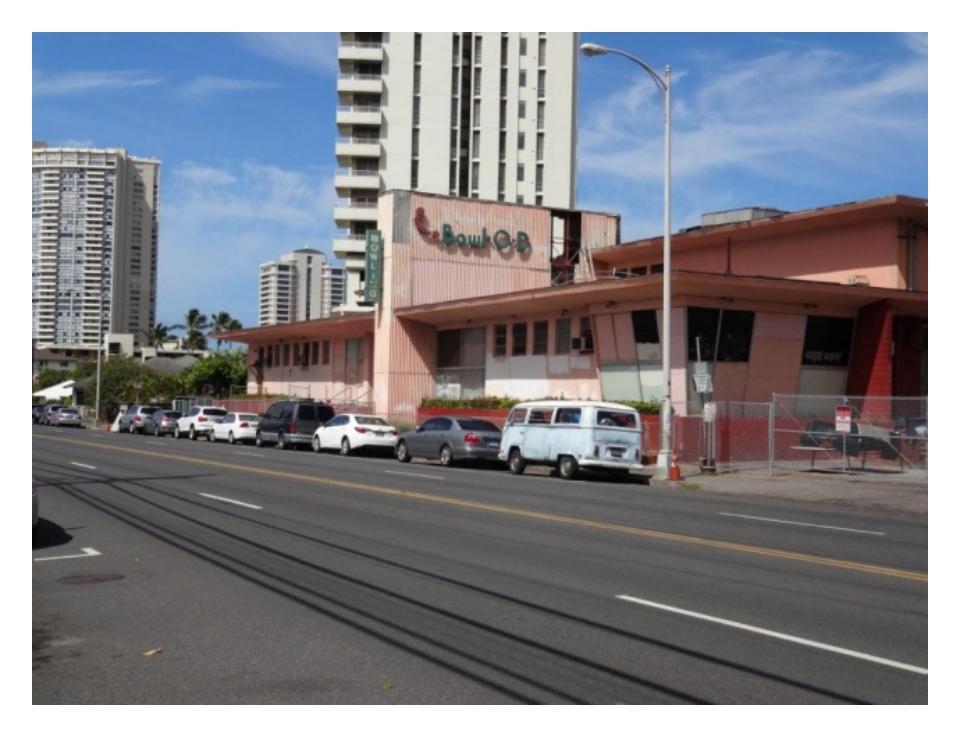
The Isenberg Street frontage of the site is generally illuminated by three street lights. The two metal pole mounted lights are located on the west side of Isenberg Street while the third street light is mounted on wood utility pole #22 at the east side of Isenberg Street.

The two street light metal poles associated with the site are located adjacent to the north and south driveways to the site. Each of the two poles is located right next to the south edge of its associated driveway.

Figure 7: Existing Street Lights at Frontage of Property
