Project Specific Asbestos, Lead Paint, and Arsenic Survey Report

**4474 Kukuihale Road
Anahola, Hawaii 96703**

4474 Kukuihale Road, Anahola (Lot 57)

Date of Report: February 22, 2022

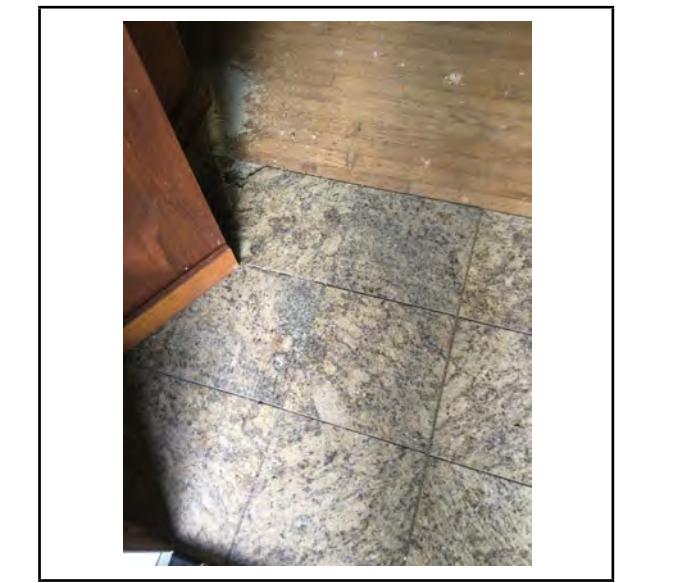
PHOTOGRAPH

Total Number of Samples Collected	0
Samples Collected by	Other
Sample Numbers	
Total Number of Samples Analyzed	0
Samples Analyzed by	Other
ASBESTOS-CONTAINING MATERIAL ?	
NO	
Number of Salient Designations:

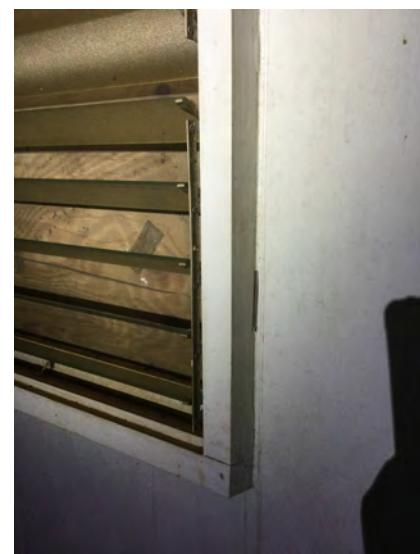
PHOTOGRAPH

Total Number of Samples Collected	3
Samples Collected by	EMET
Sample Numbers	615-4474-1H1, 615-4474-1H2, 615-4474-1H3
Total Number of Samples Analyzed	3
Samples Analyzed by	EMET
ASBESTOS-CONTAINING MATERIAL ?	
Number of Salient Designations:

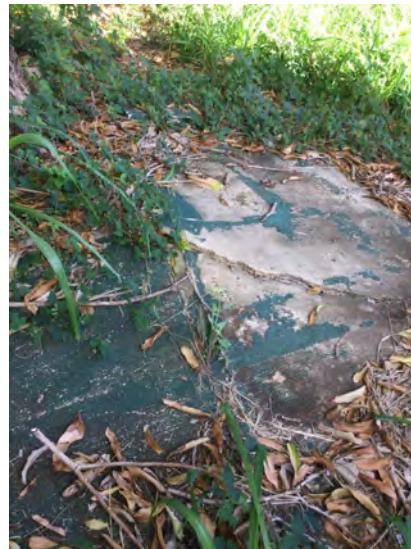
PHOTOGRAPH

Total Number of Samples Collected	3
Samples Collected by	EMET
Sample Numbers	615-4474-1I1, 615-4474-1I2, 615-4474-1I3
Total Number of Samples Analyzed	3
Samples Analyzed by	EMET
ASBESTOS-CONTAINING MATERIAL ?	
Number of Salient Designations:

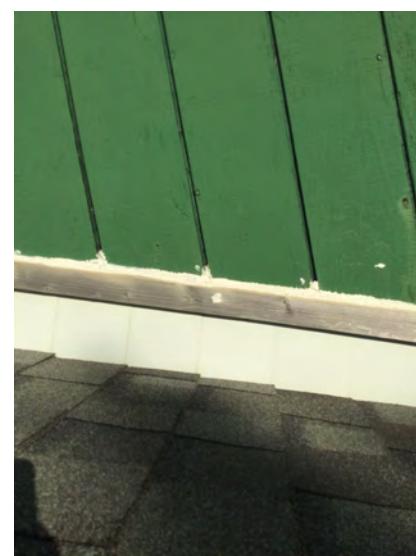
PHOTOGRAPH

Total Number of Samples Collected	3
Samples Collected by	EMET
Sample Numbers	615-4474-LRC1, 615-4474-LRC2, 615-4474-LRC3
Total Number of Samples Analyzed	3
Samples Analyzed by	EMET
ASBESTOS-CONTAINING MATERIAL ?	
Number of Salient Designations:

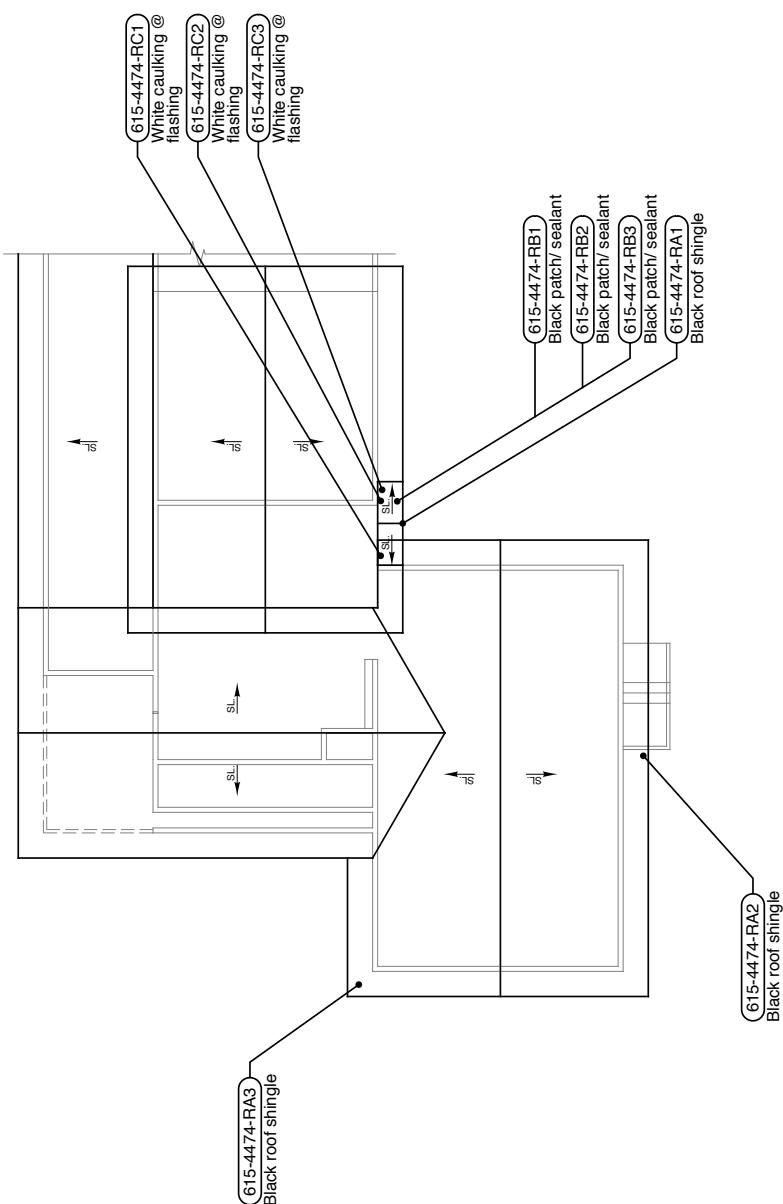
4474 KUKUIHALE RD - PARTIAL ROOF PLAN
NOT TO SCALE

NORTH	ASBESTOS-CONTAINING MATERIALS (ACM)*: NO ACM DETECTED IN AREAS SAMPLED		
<p>* ASBESTOS-CONTAINING MATERIAL (ACM) IS DEFINED AS ANY MATERIAL CONTAINING > 1% ASBESTOS.</p> <p>THIS SURVEY WAS LIMITED IN SCOPE TO SPECIFIC AREAS AFFECTED BY PLANNED RENOVATION ACTIVITIES ONLY; THEREFORE, THIS REPORT MAKES NO WARRANTY FOR AREAS OF THE BUILDING WHICH WERE NOT INCLUDED IN THE SCOPE OF THE SURVEY.</p>
