HAWAII ISLAND STRUCTURE DEMOLITION & CLEARING

IFB-22-HHL-020

HAZARDOUS MATERIALS SURVEY REPORT
82 Andrews Avenue Lot No. 58-B-1, TMK (3) 2-1-021:072
Hilo, Hawaii

Photo Log
Seven homes on the Big Island of Hawai'i
82 Andrews Avenue Lot No. 58-B-1, TMK (3) 2-1-021:072
MEC Project No.: 2022-0034

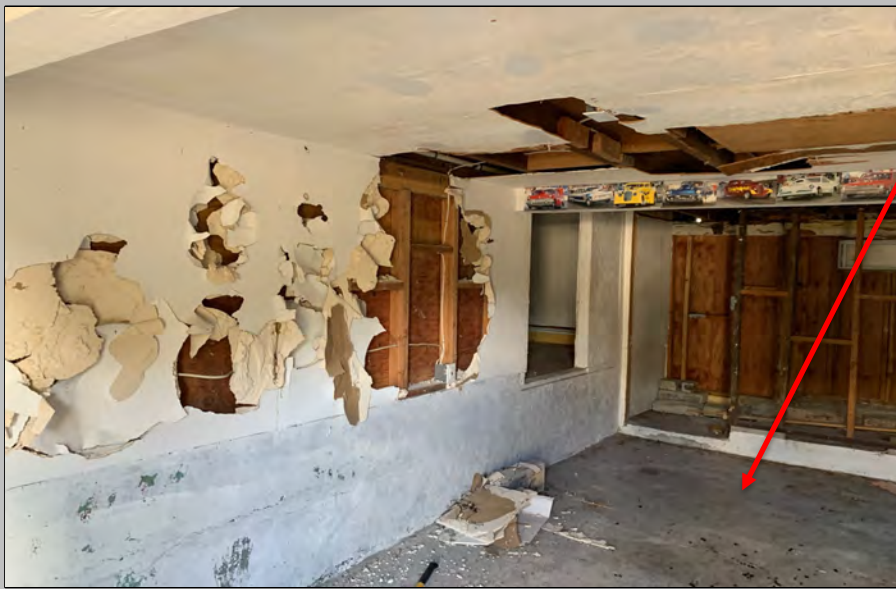
Photo No. 2: Downstairs

Lead-Containing Paint	Location	Condition	Estimated Quantity (Affected Area)
Gray paint on concrete floor (Photo 2)	Downstairs floor	Damaged	212.48 ft ²
White paint on concrete floor (Photo 3)	Downstairs floor	Damaged	148.15 ft ²
Green paint on concrete wall (Photo 4)	Outside the House	Damaged	5 ft ²

Lead-containing gray paint on concrete floor.

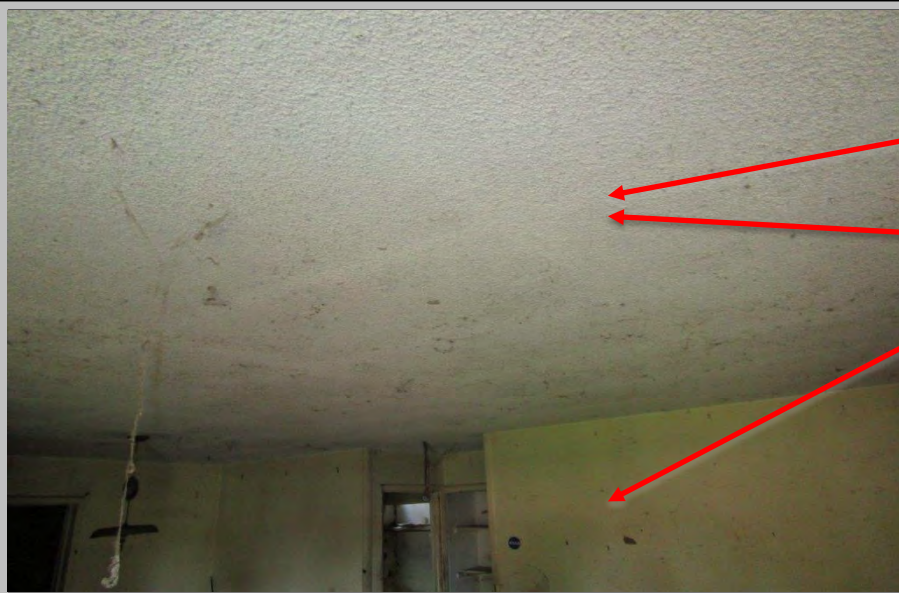
Photo No. 2: Living Room

Asbestos-containing white popcorn ceiling.

White drywall did not contain asbestos.

Tan paint on drywall wall did not contain lead.

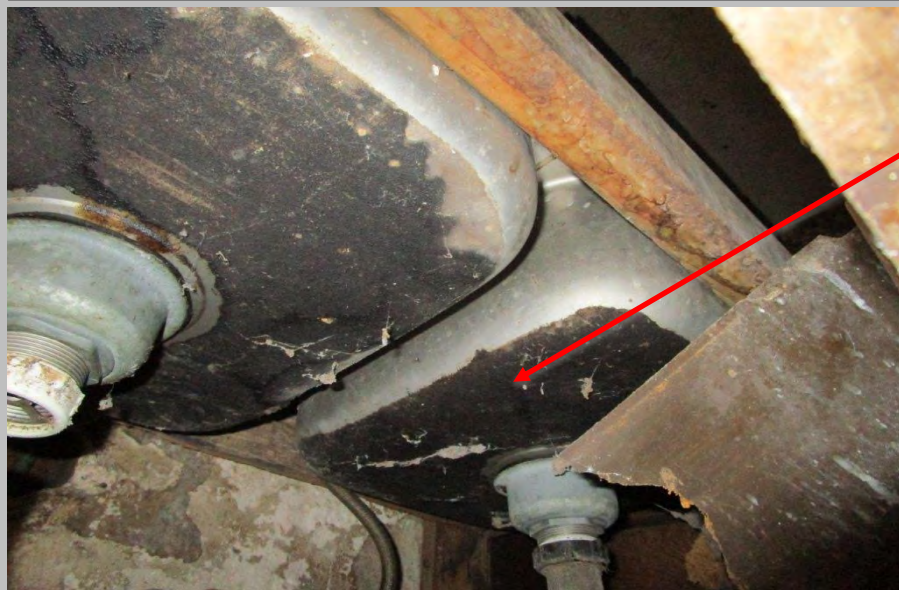
Photo No. 3: Kitchen

Asbestos-containing black sink undercoating.

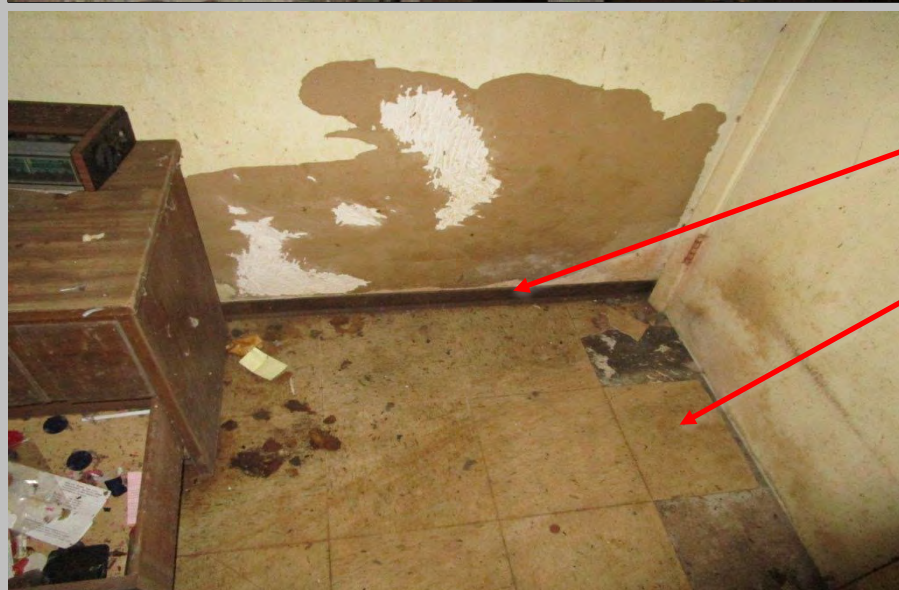
Photo No. 4: Bedroom #2

Cove base under the tiles was not asbestos-containing.

Asbestos-containing 9"x 9" tan with beige streak vinyl floor tiles with black mastic underneath.

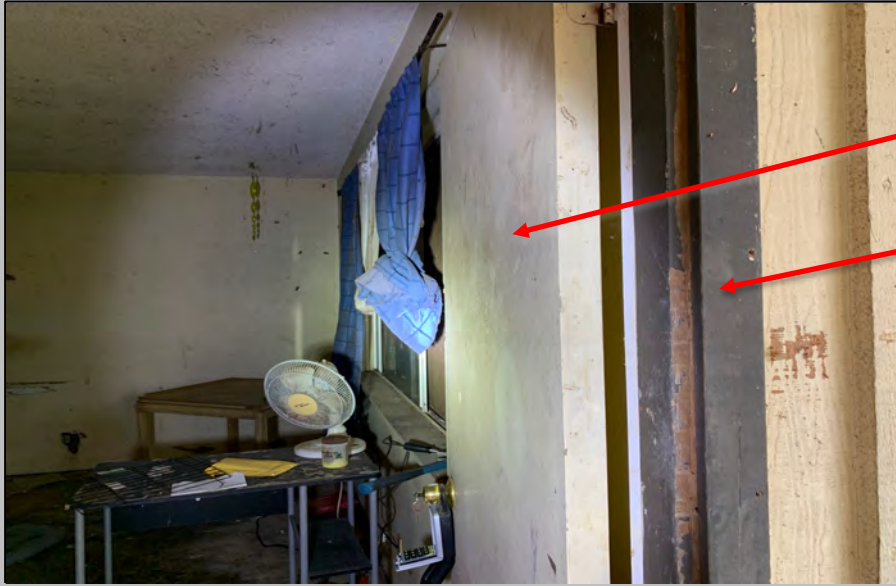
Photo No. 5: Entry of House

Lead-Containing Paint	Location	Condition	Estimated Quantity (Affected Area)
Tan paint on wood door (Photo 5)	Entry door	Good	21 ft ²

Lead-containing tan paint on wood door.

Brown paint on wood door frame did not contain lead.

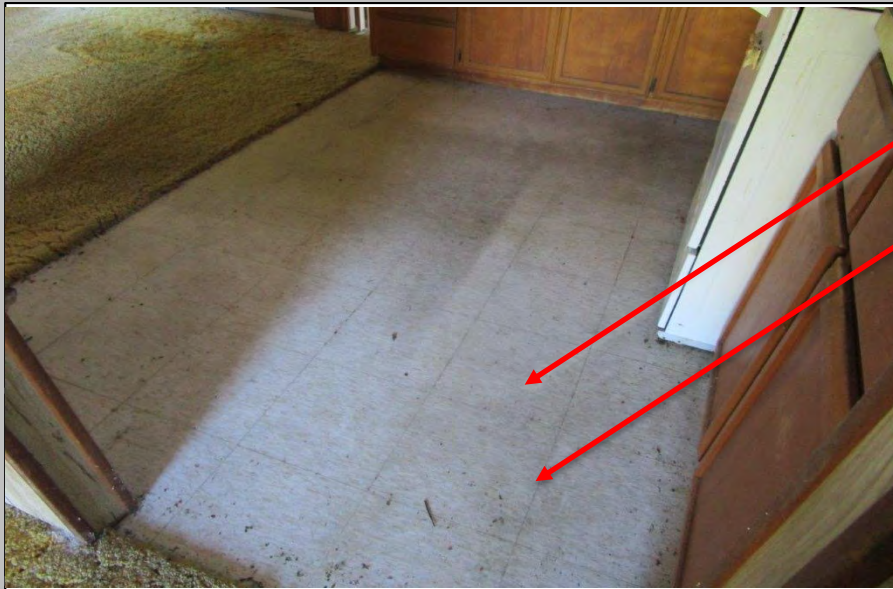
Photo No. 2: Kitchen

Asbestos-Containing Materials	Location	Condition	Estimated Quantity (Affected Area)
Beige floor tile (Photo 2)	Kitchen	Damaged	47 ft ²
Black sink undercoating (Photo 3)	Kitchen	Damaged	8 ft ²

Asbestos-containing beige vinyl floor tiles.

Yellow mastic did not contain asbestos.

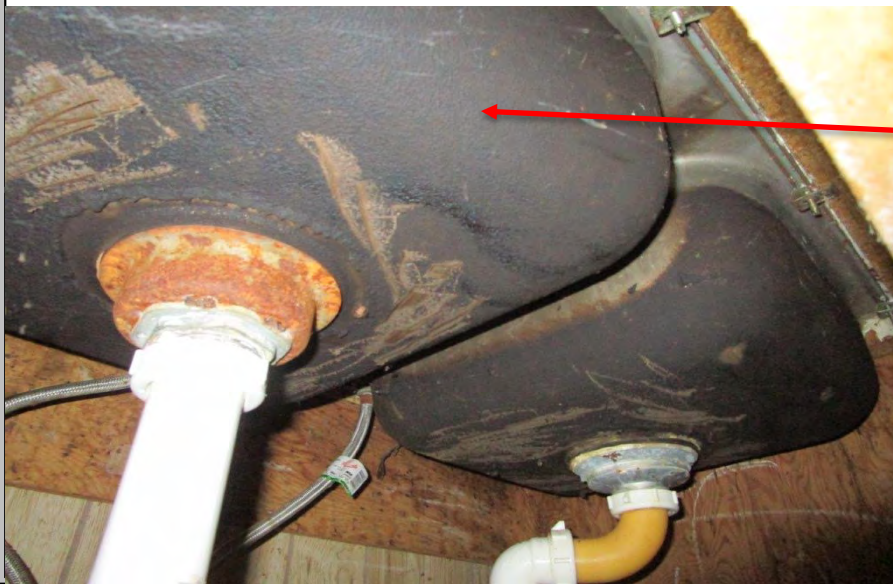
Photo No. 3: Kitchen

Asbestos-containing black sink undercoating.

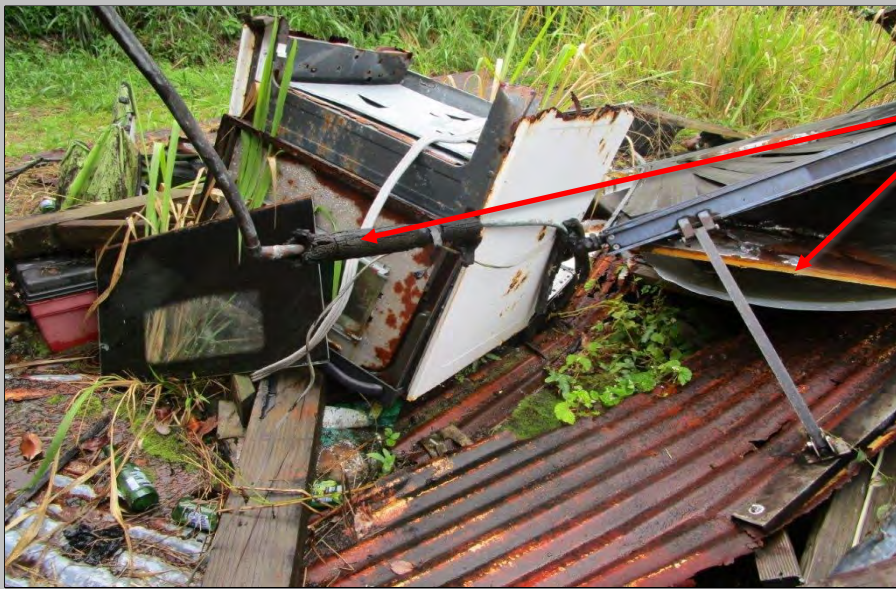
Photo No. 2: Exterior of house

Black foam insulation and silver wrap/yellow foam insulation did not contain asbestos.

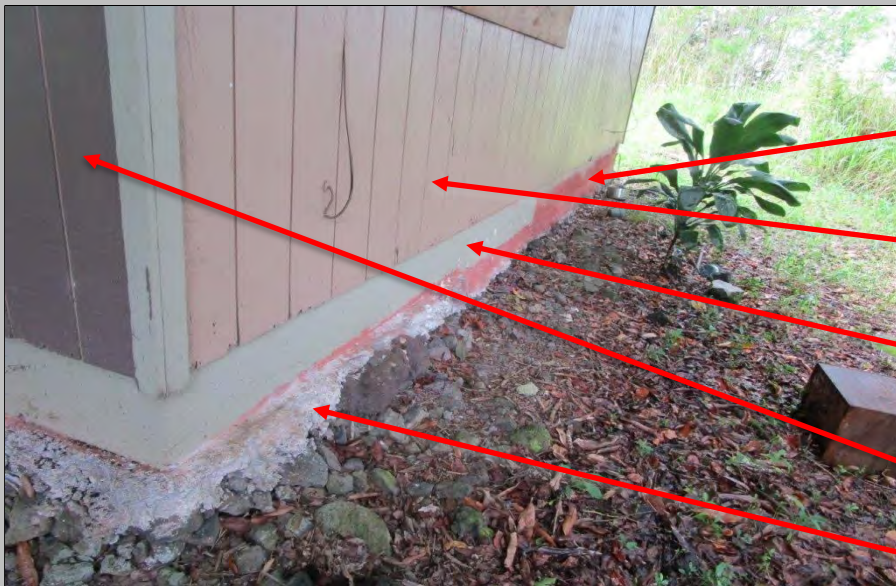
Photo No. 3: Exterior of house

Red paint on wood wall did not contain lead.

Brown paint on wood wall did not contain lead.

Gray concrete did not contain asbestos.

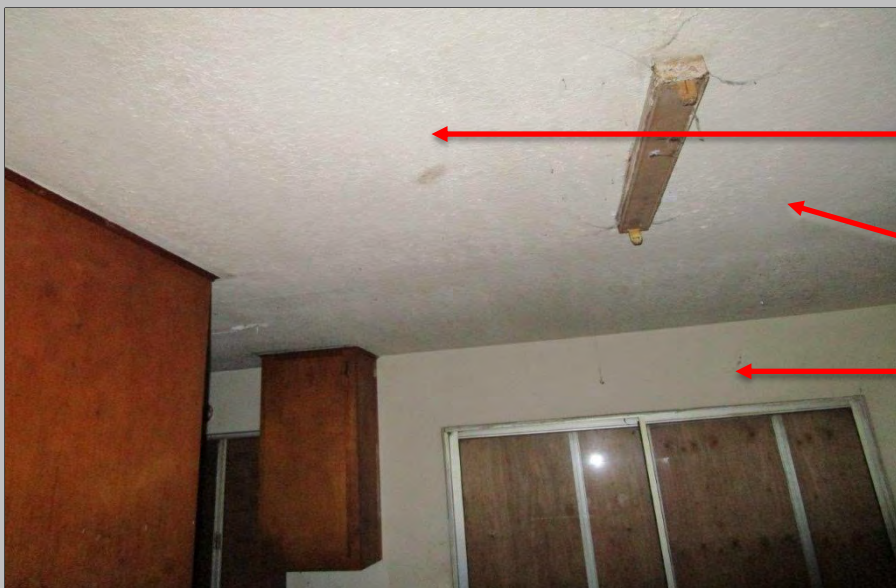
Photo No. 4: Living Room

White drywall and white texture/white paint did not contain asbestos.

White paint on ceiling did not contain lead.

Light grey paint on drywall wall did not contain lead.

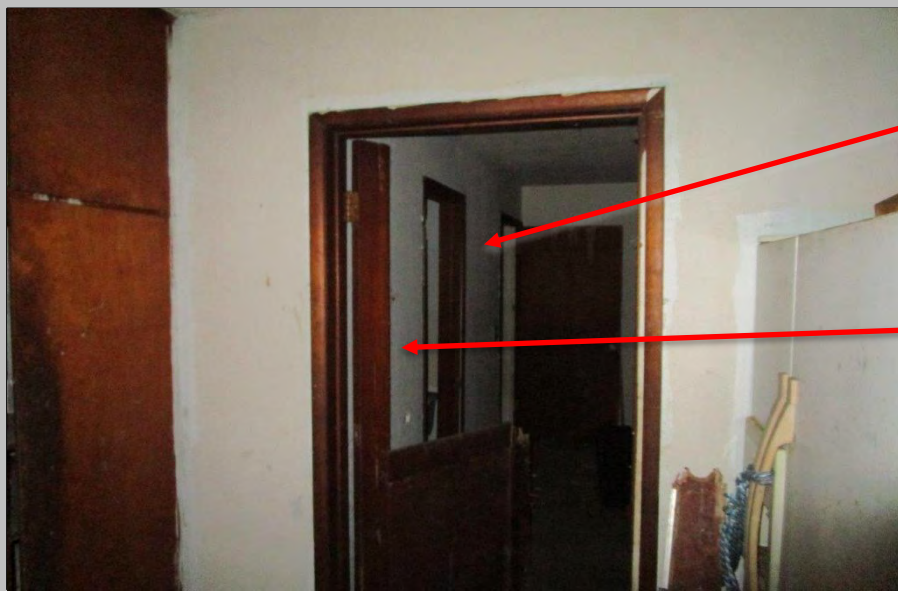
Photo No. 5: Living Room Hallway

White drywall, white texture/white paint, white texture/green paint, and white texture/purple paint did not contain asbestos.

White paint on drywall wall did not contain lead.

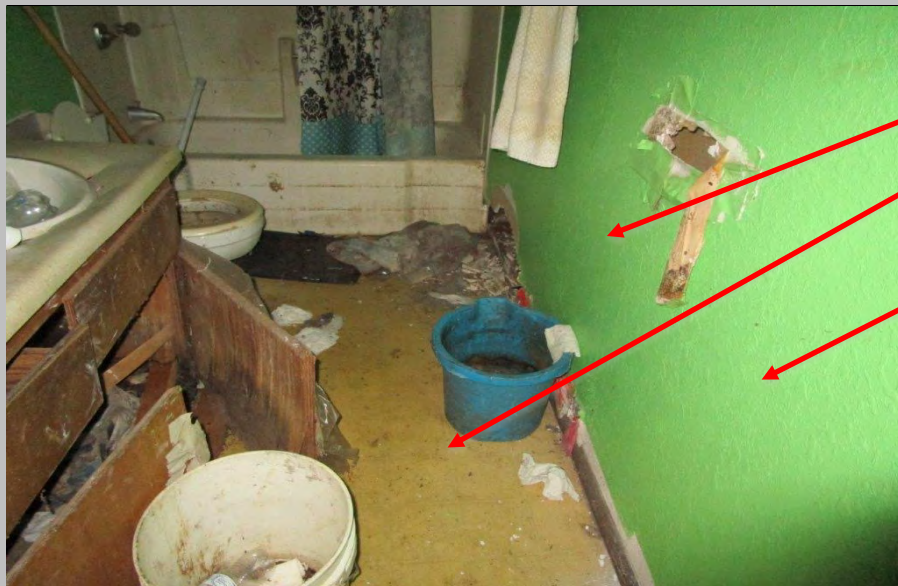
Photo No. 6: Bathroom

White drywall, white texture/green paint, and beige sheet vinyl with paper backing did not contain asbestos.

Light green paint on drywall wall did not contain lead.

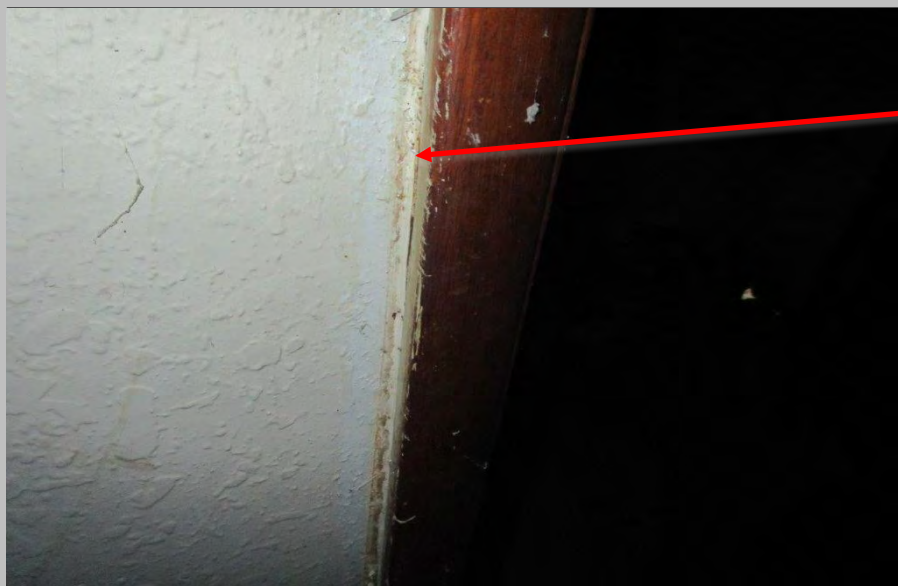
Photo No. 7: Kitchen

White caulking did not contain asbestos.

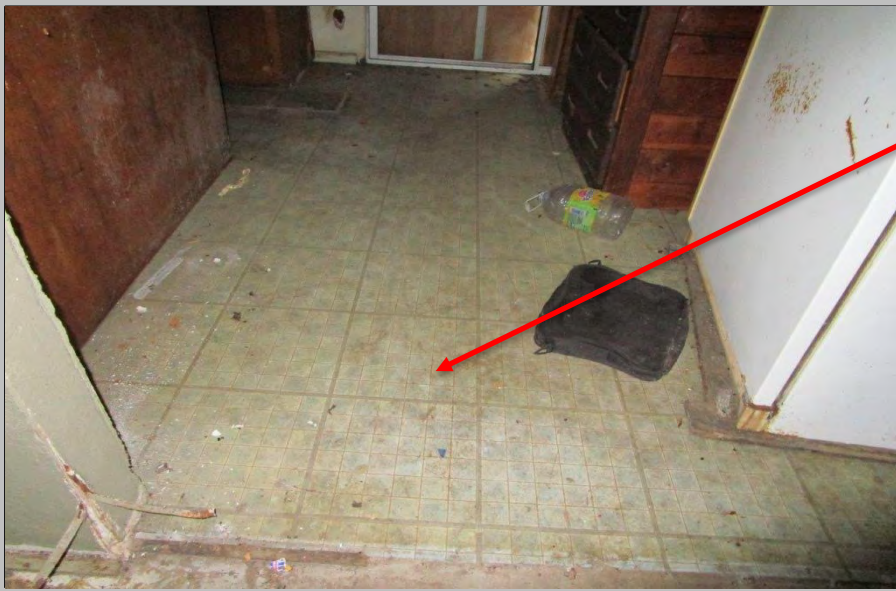
Photo No. 8: Kitchen

Blue floor tile and yellow mastic did not contain asbestos.

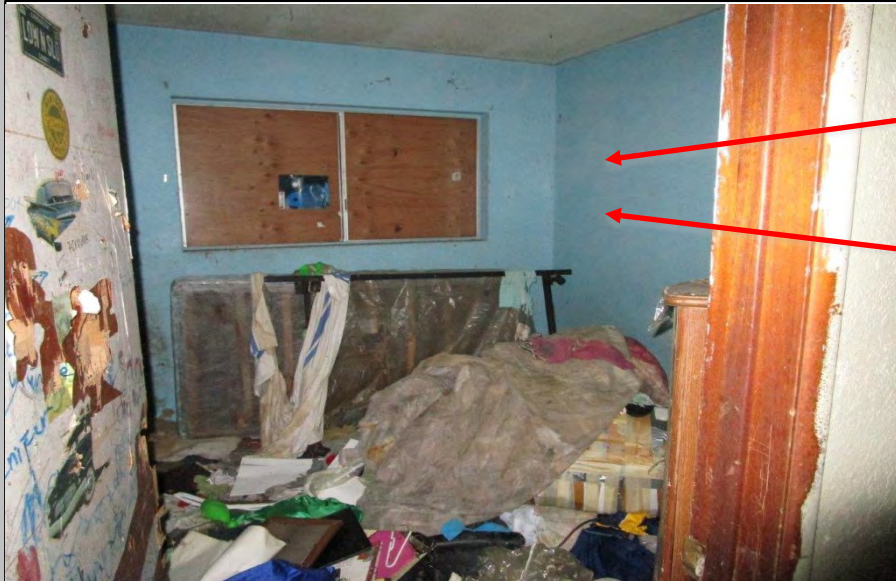
Photo No. 9: Bedroom #5

White drywall, and white texture/blue paint did not contain asbestos.

Baby blue paint on drywall wall did not contain lead.

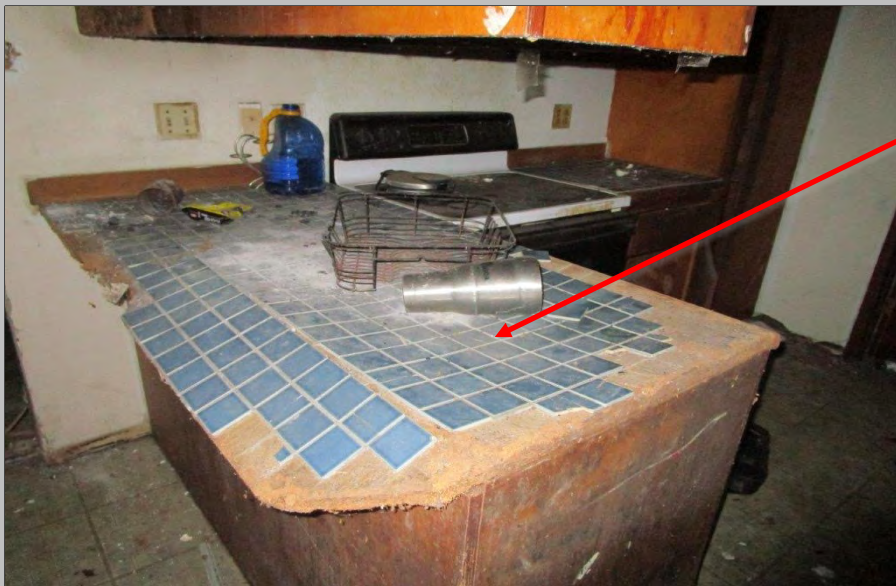
Photo No. 10: Kitchen

Blue ceramic tile/mesh and gray grout did not contain asbestos.

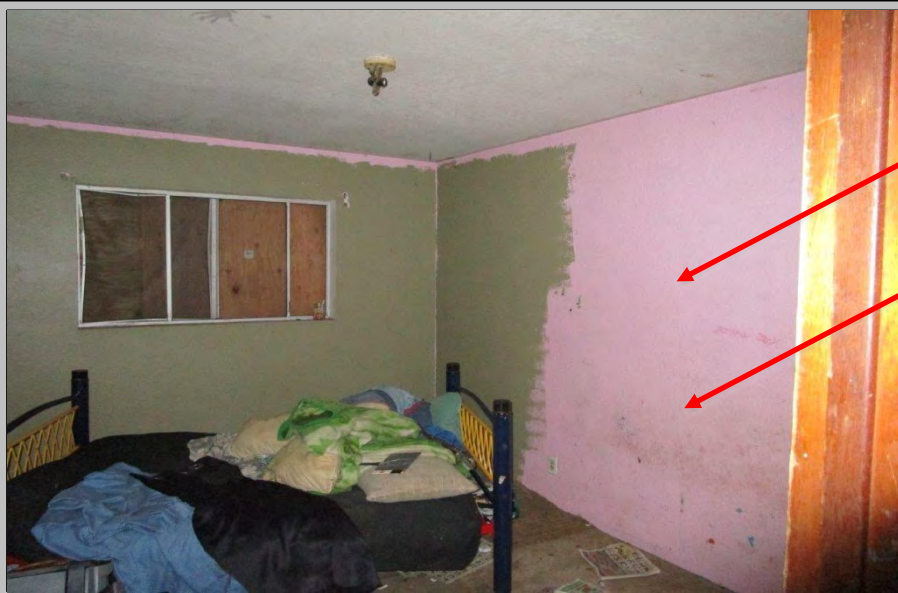
Photo No. 11: Bedroom #1

White drywall, white joint compound/paper and white texture/pink paint did not contain asbestos.

Pink paint on drywall wall did not contain lead.

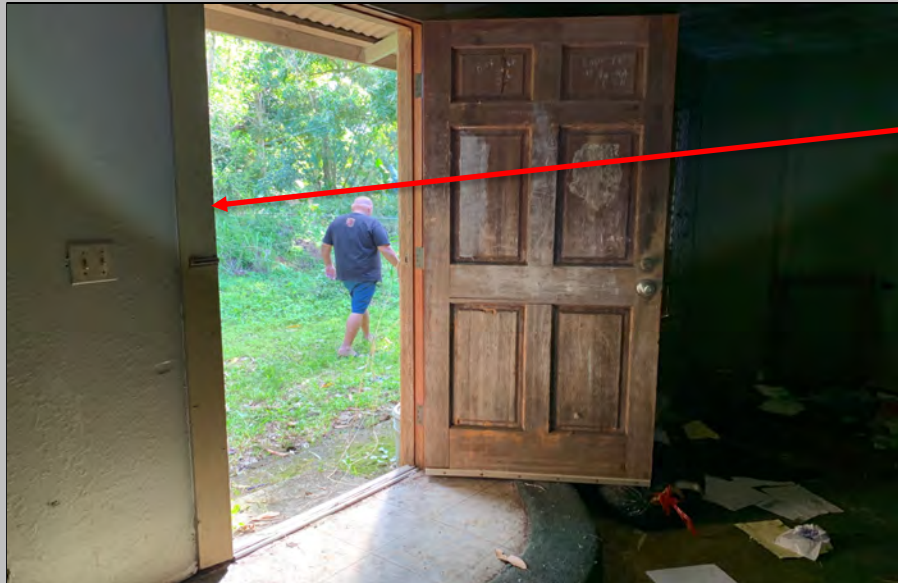
Photo No. 12: Front Door

Sand paint on wood door frame did not contain lead.

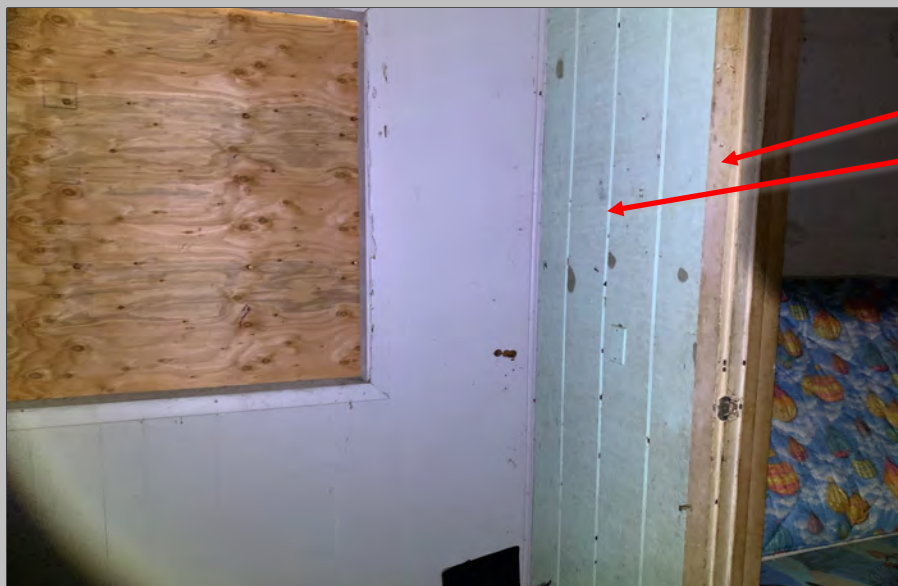
Photo No. 13: Bedroom #3

White paint on wood door frame and green paint on drywall wall did not contain lead.

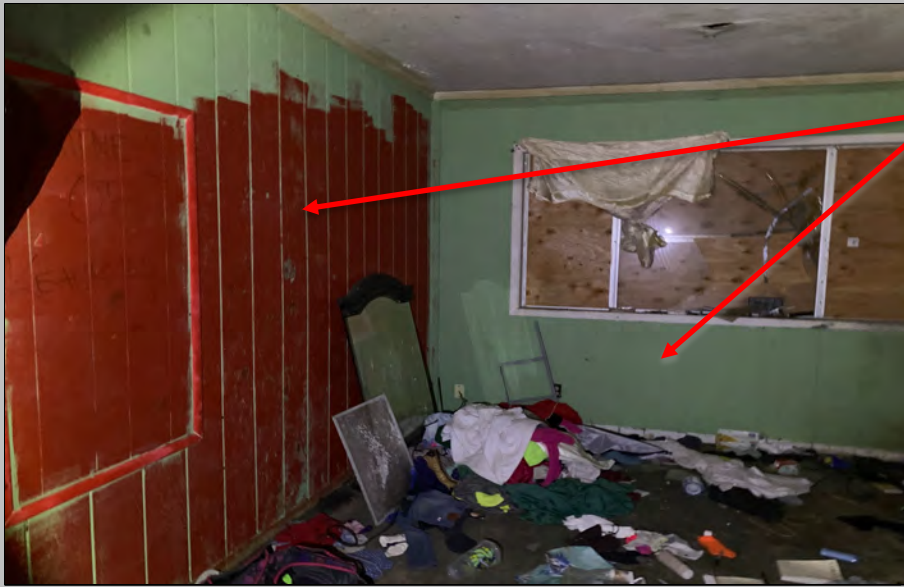
Photo No. 14: Bedroom #3

Red paint on drywall wall and green paint on drywall did not contain lead.

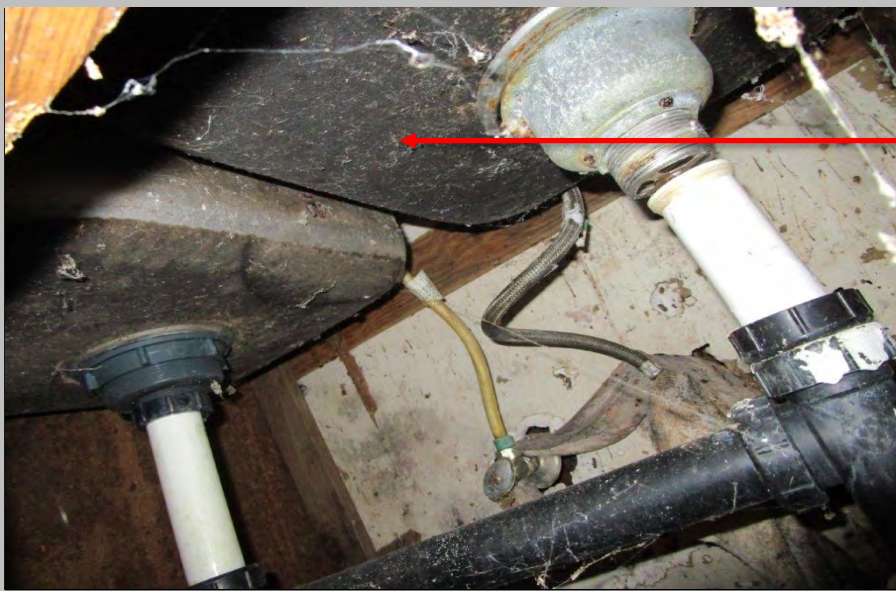
Photo No. 2: Kitchen

Asbestos-containing black sink undercoating.

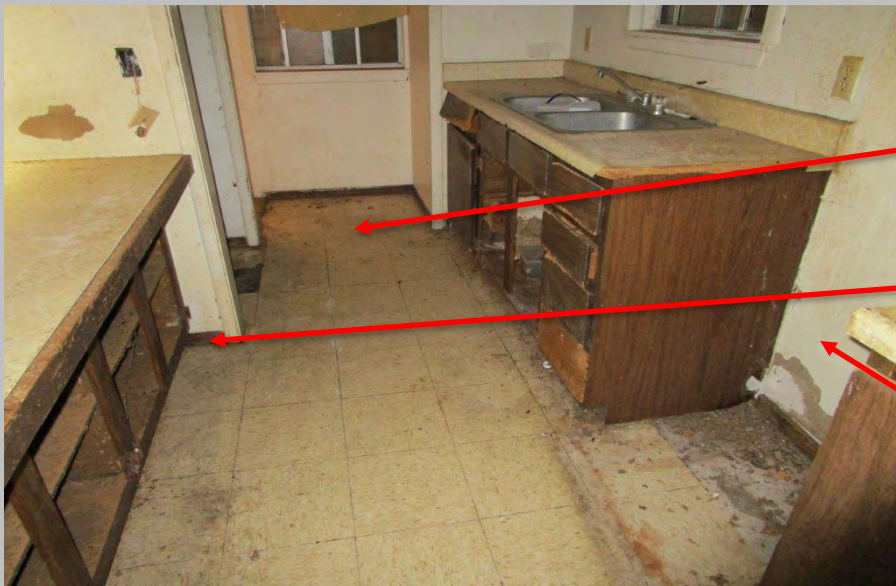
Photo No. 3: Kitchen

Asbestos-containing beige floor tile with black mastic underneath.

Brown cove base and tan/brown mastic was not asbestos-containing.

Asbestos-containing white joint compound.

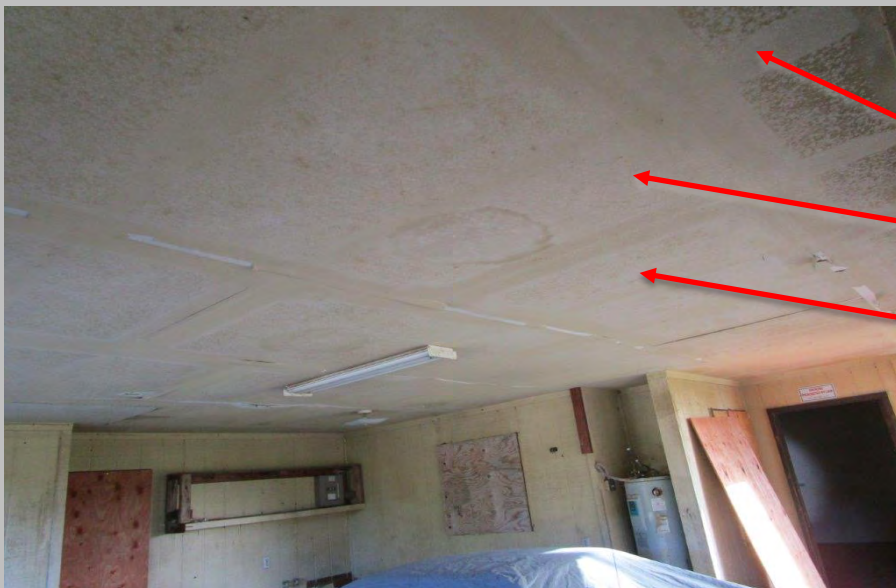
Photo No. 4: Carport

Asbestos-containing white joint compound/off-white paint.

White drywall did not contain asbestos.

White paint on drywall ceiling did not contain lead.

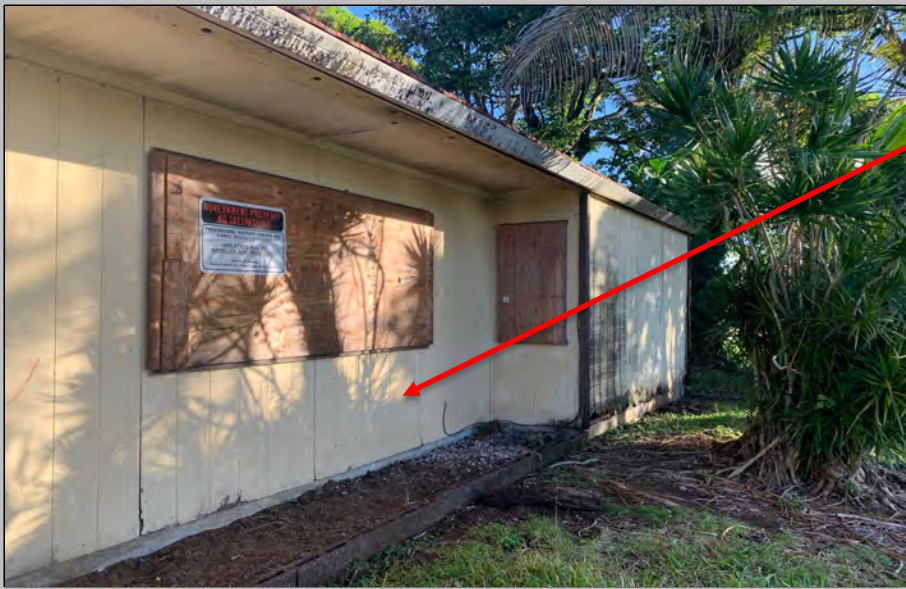
Photo No. 5: Exterior walls

Lead-Containing Paint	Location	Condition	Estimated Quantity (Affected Area)
Yellow paint on wood walls (Photo 5)	Exterior walls	Damaged	5,784 ft ²

Lead-containing yellow paint on wood walls.

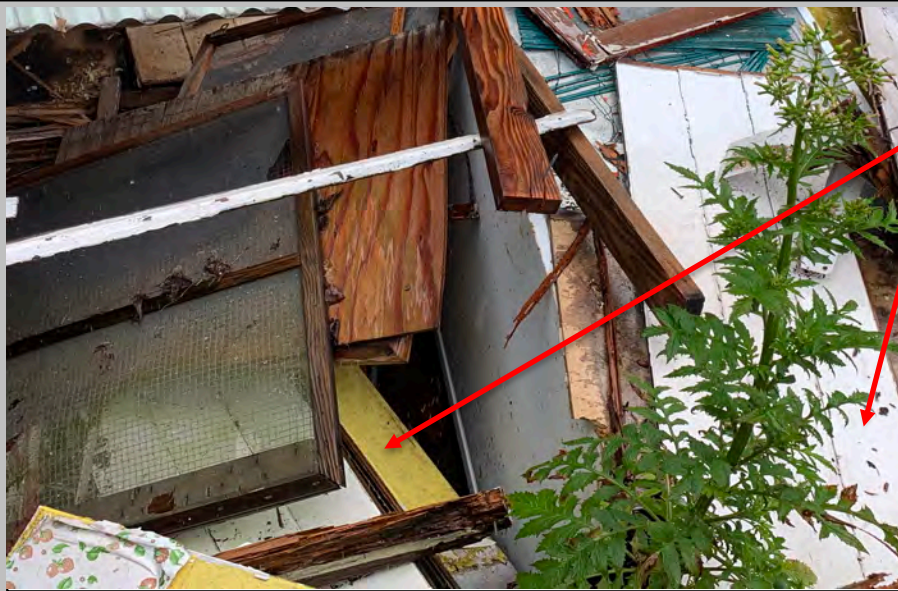
Photo No. 2:

Lead-containing and lead-based yellow paint on wood.

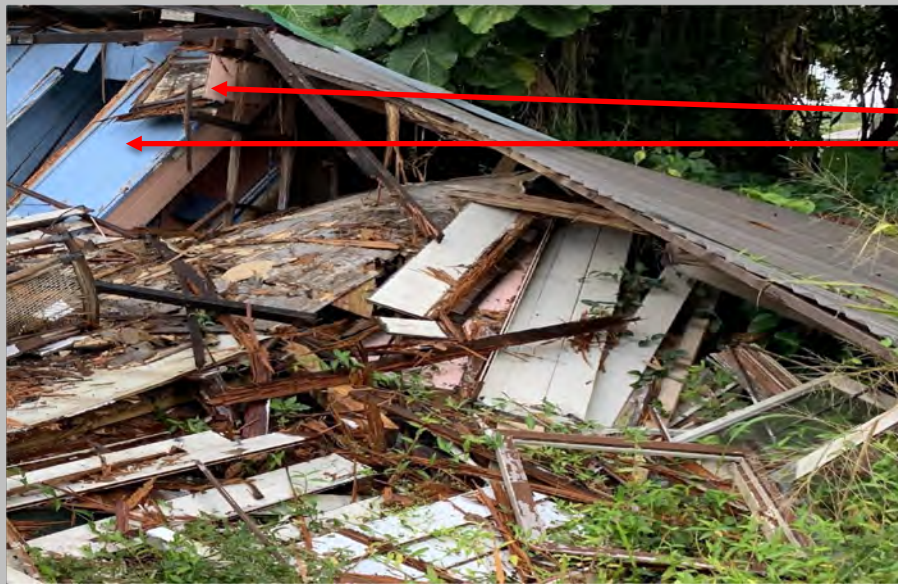
Photo No. 4:

Lead-containing pink paint on wood and blue paint on wood.

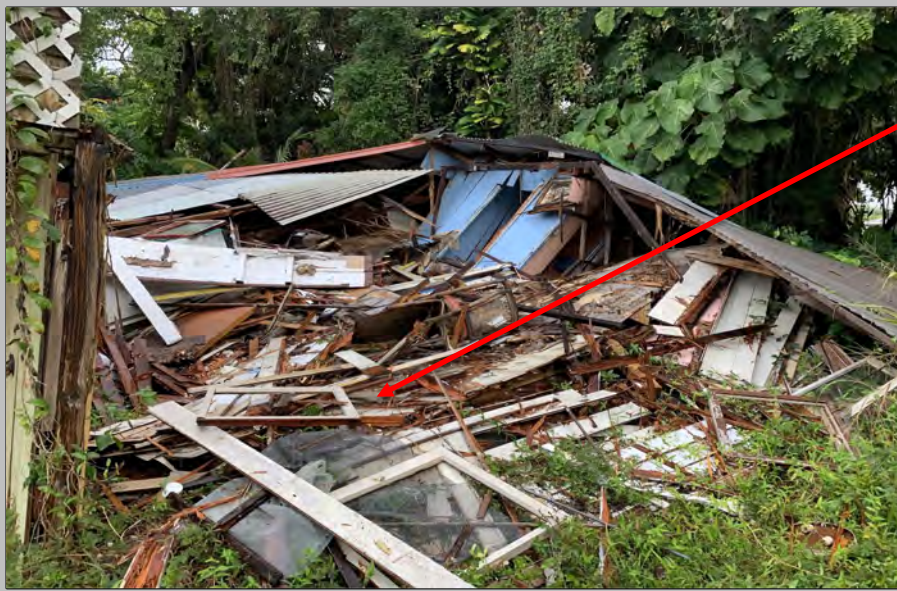
Photo No. 5:

Lead-containing gray paint on wood.

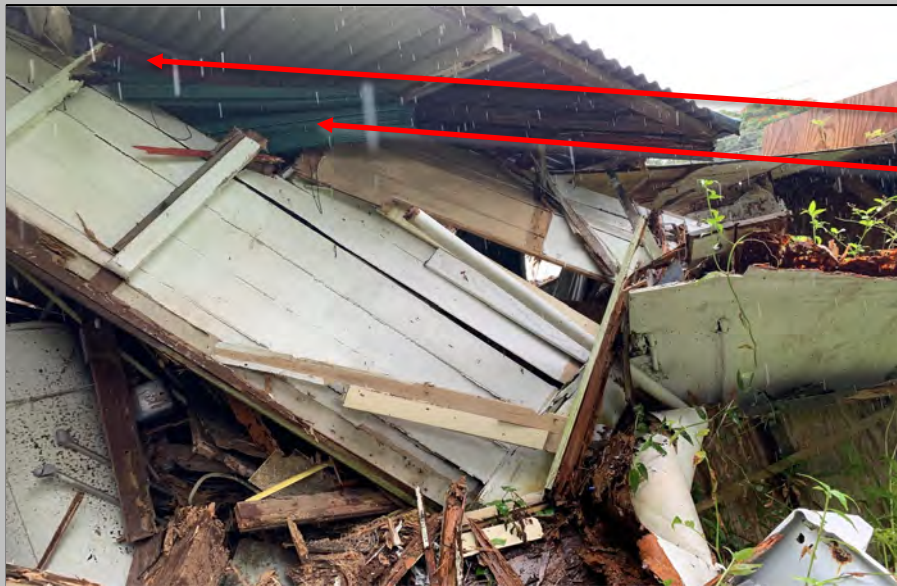
Photo No. 6:

Lead-containing red paint on wood window frame and green paint on wood.

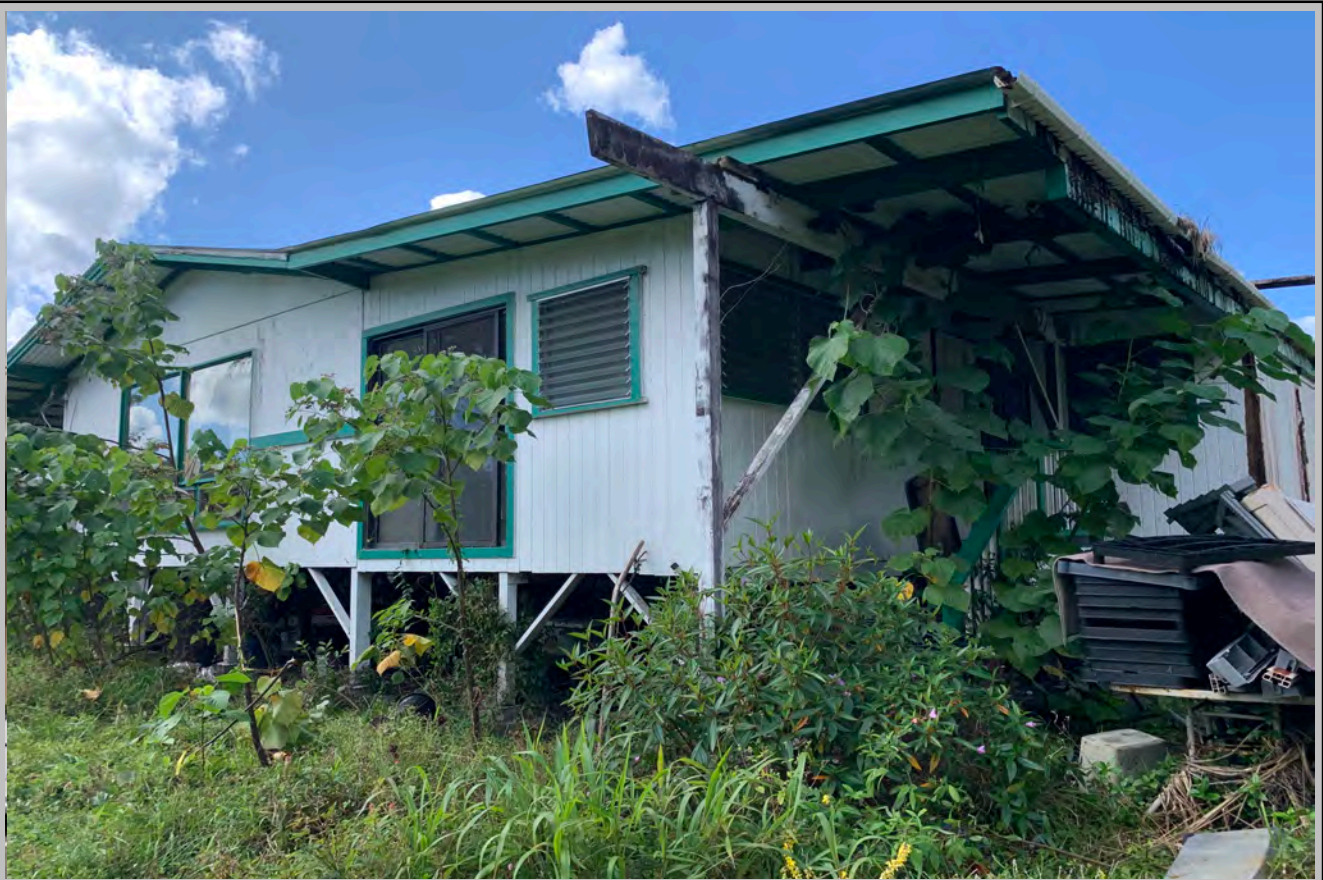
Photo No. 1:
Front view of the Home

1420 Auwae Road Lot No. 70B, TMK (3) 2-1-025:192 was a one-story house on stilts (Photo no. 1). The interior and exterior paint of the house was fading and peeling in various locations. Furniture was found scattered throughout the house. The ceiling was falling in various locations. The roof consisted of corrugated sheet metal, had no mastic and was factory painted. We were unable to collect paint samples of the roof therefore assume the roof paint is positive for lead.

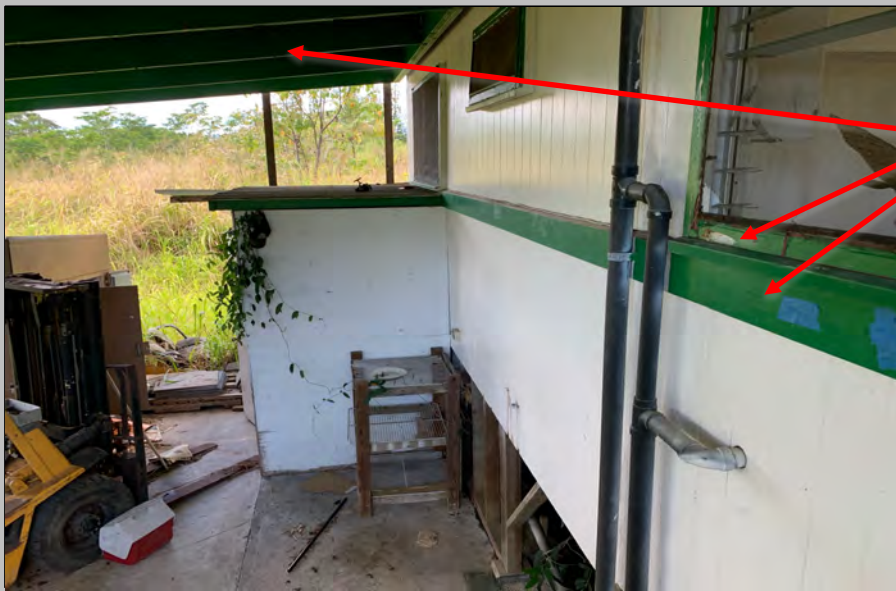
Photo No. 2: Under Overhang

Lead-Containing Paint	Location	Condition	Estimated Quantity (Affected Area)
Green paint on wood (Photo 2)	Exterior beams, walls, window frame, door trim	Good	198 ft ²
White paint on wood wall (Photo 3)	Exterior wall	Good	841.44 ft ²
White paint on compressed board (Photo 4)	Ceiling of hallway, bathroom, bedroom	Good	317 ft ²

Lead-containing green paint on wood exterior beams, walls, window frame and door trim.

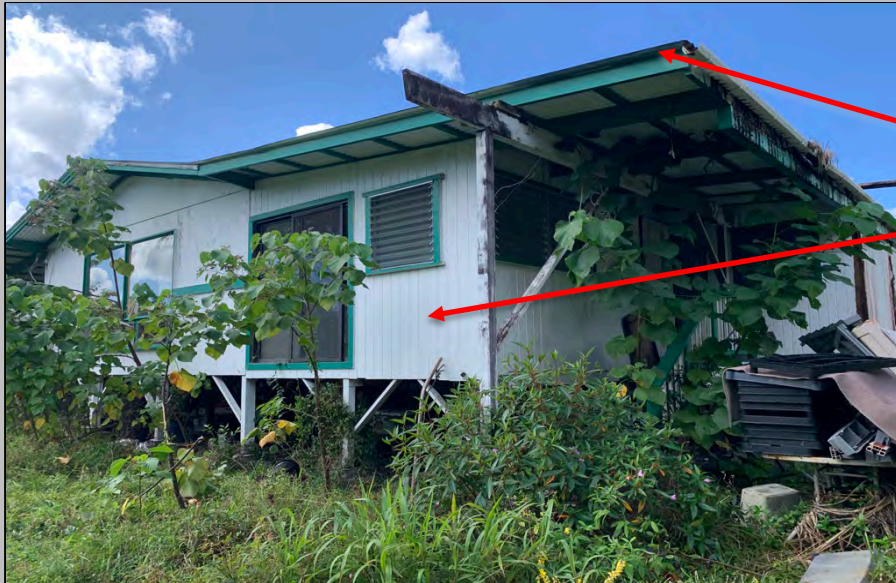
Photo No. 3: Outside the house

Roof was corrugated roofing, had no mastic and was factory painted.

Lead-containing white paint on wood wall.

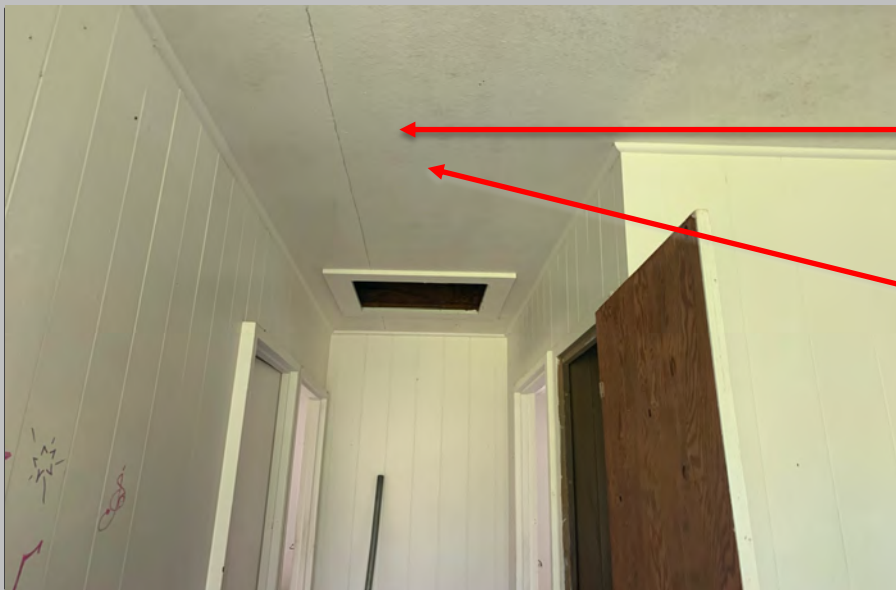
Photo No. 4: Hallway

Arsenic containing materials were found on the ceiling of the hallway, bathroom, and bedroom. See summary of Arsenic containing building materials below for materials, locations, and estimated quantity and Section 6.3 Arsenic for recommendations.

Arsenic-containing and lead-containing white paint on compressed board.

White compressed board was not asbestos-containing.
