WAIAKEA RESIDENCE LOTS UNIT I (PLAT 3.2 H.H)

SURVEY MAP

LOT 8
HILO SCATTERED LOTS
KAUMANA SUBDIVISION
UNIT I (F.P. 2476)

SITUATED AT KAUMANA AND PONAHAWAI, SOUTH HILO, ISLAND OF HAWAII, HAWAII 1810 UHALOA ROAD

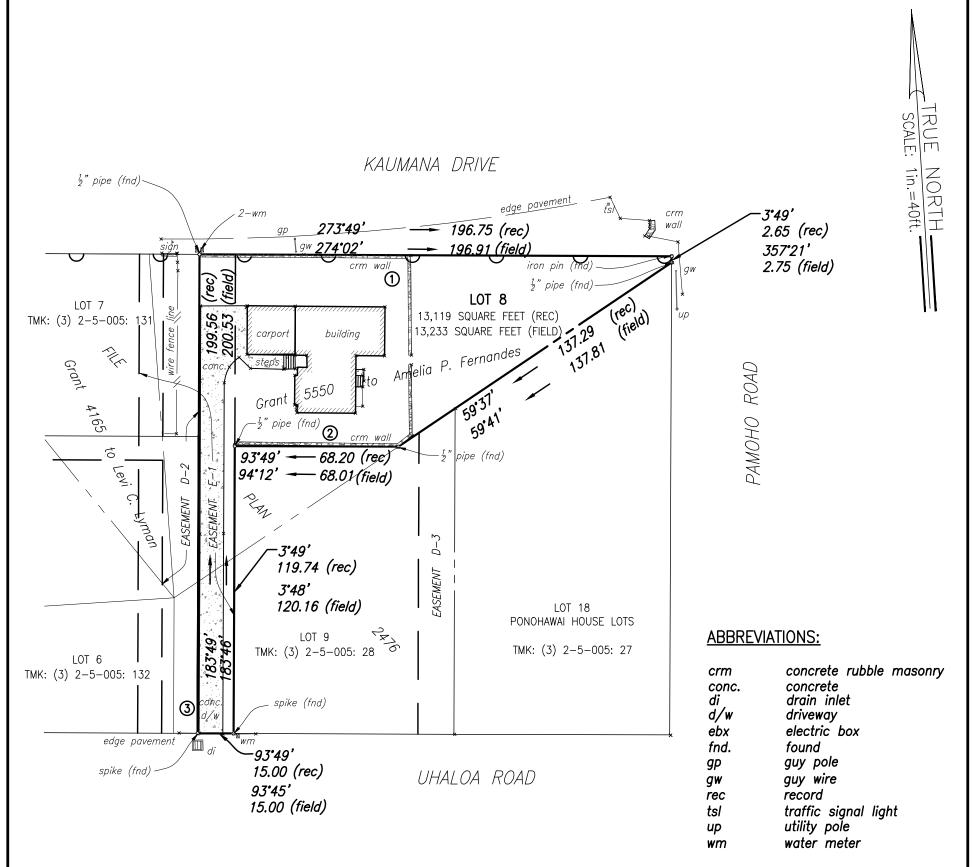
- (1) CRM wall along the North boundary is entirely within subject Lot 8.
- 2 CRM wall along the Southerly boundary is entirely within subject Lot 8.
- 3 Concrete driveway along the West boundary is entirely within subject Lot 8
